Stripper foil failure modes and cures at the Oak Ridge Spallation Neutron Source

M. A. Plum,* S. M. Cousineau, J. Galambos, S. H. Kim, P. Ladd, C. F. Luck, C. C. Peters, Y. Polsky, and R. W. Shaw
Oak Ridge National Laboratory, Oak Ridge, Tennessee 37831, USA

The Oak Ridge Spallation Neutron Source comprises a 1 GeV, 1.5 MW linear accelerator followed by an accumulator ring and a liquid mercury target. To manage the beam loss caused by the H^0 excited states created during the H^- charge-exchange injection into the accumulator ring, the stripper foil is located inside one of the chicane dipoles. This has some interesting consequences that were not fully appreciated until the beam power reached about 840 kW. One consequence was sudden failure of the stripper foil system due to convoy electrons stripped from the incoming H^- beam, which circled around to strike the foil bracket and cause bracket failure. Another consequence is that convoy electrons can reflect back up from the electron catcher and strike the foil and bracket. An additional contributor to foil system failure is vacuum breakdown due to the charge developed on the foil by secondary electron emission. In this paper we d

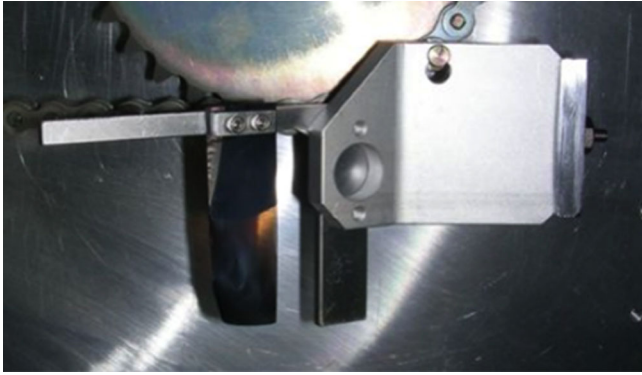
FIG. 1. A used first generation foil and bracket mounted on the foil-changer mechanism. The long arm and leg of the L-shaped bracket were designed to stretch carbon fibers across the span to support foils if needed (not needed in this case). (The figure was reproduced from Ref. [13].)

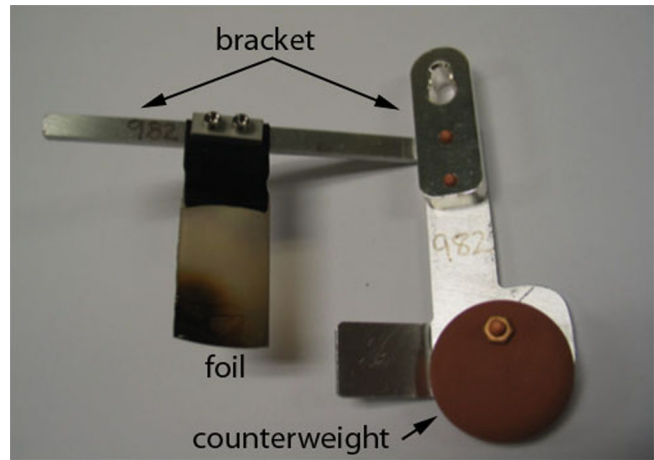
FIG. 2. A used second-generation foil bracket. The beam power in this case was only 400 kW, so this foil and bracket show very little damage. (The figure was reproduced from Ref. [13].)

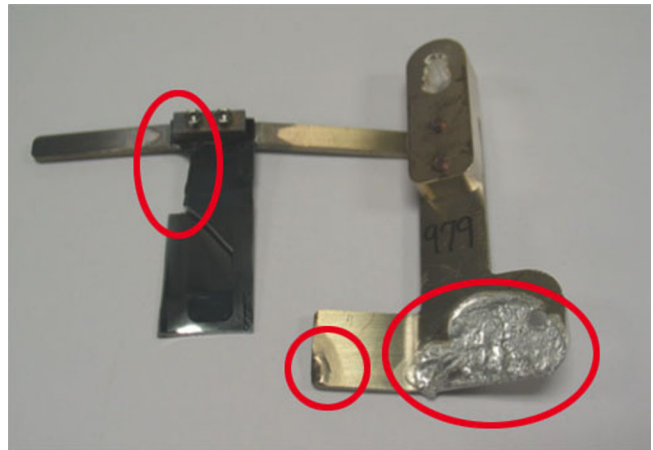
FIG. 3. A failed second-generation foil and bracket. The two lower ellipses indicate the melting damage caused by the electrons. The upper ellipse indicates where the silicon substrate fractured due to forces at the mounting point. This foil lasted for a few hours at ~ 840 kW beam power. The convoy electrons struck the bottom-left corner of the tab on the leg of the bracket, and the subsequent heating caused the bracket to melt where the counterweight was attached. (The figure was reproduced from Ref. [13].)

The large melted area on the lower right shows where a circular counterweight was attached before the material around the mounting hole melted, causing the counterweight to fall off. Convoy electron damage can also be seen on the first generation foil brackets, but the beam power was low when these brackets were in use, the damage was minor, and at the time we considered it to be a curiosity. To alleviate this failure mechanism the foil was moved 1 cm further out on the bracket starting with a portion of the third-generation foils and brackets installed May 19, 2009.

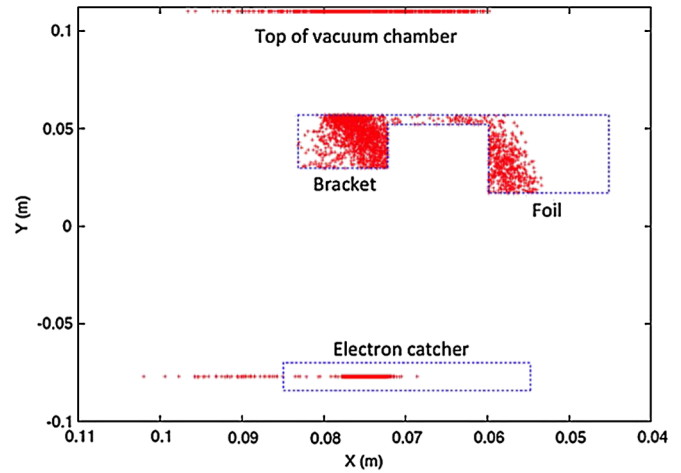
FIG. 4. The results of a particle tracking simulation, for the case of a third-generation foil and bracket, showing the locations where the reflected convoy electrons strike the electron catcher, the stripper foil, the bracket, and the top and bottom of the vacuum chamber.

reflecting surface in the model located halfway up the height of the actual carbon wedges. The reflected electrons can strike the stripper foil, the bracket, the top of the vacuum chamber, or even the bottom of the vacuum chamber (due to magnetic reflections). The model predicts that, for the convoy electrons that do not strike the undercut faces of the electron catcher, (3–17)% will strike the foil, (0–1)% will strike the arm of the foil bracket, and (7–25)% will strike the leg of the foil bracket, where the ranges are calculated by varying the elevation of the reflecting surface from the bottom of the wedges to the top.

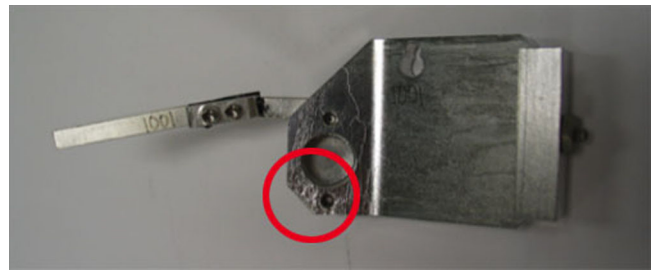
Physical evidence for convoy electrons striking the foil bracket can be found, for example, on the third-generation foil bracket shown in Fig. 5. The lower leg of this bracket was removed so that the convoy electrons would not strike it as they travel down to the electron catcher, yet it still shows melting damage on the lower left corner, and the arm of the bracket has also softened enough to allow the arm to droop down. This bracket was used for beam powers up to about 850 kW, and in this case the convoy electron power is 926 W. Based on the simulations discussed above,

FIG. 5. A used third-generation foil bracket. Melting damage is indicated by the circle. (The figure was reproduced from Ref. [13].)

the power striking the bracket leg could have been as high as (7–25)% of 926 W, or 65–232 W. We do not have a quantitative measurement of how many convoy electrons are actually caught by the electron catcher and how many are reflected, but finite element analysis simulations predict that just 10 W directed onto the corner of the bracket is sufficient to cause melting damage.

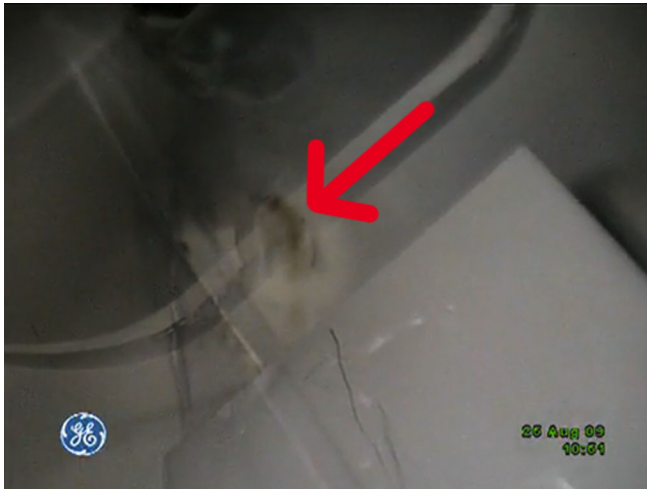
FIG. 6. A photograph of the upper inside surface of the vacuum chamber above the stripper foil. The black ring, indicated by the arrow, is likely due to graphitization caused by reflected convoy electrons.

Further evidence of reflected convoy electrons can be found on the upper surface of the vacuum chamber above the stripper foil. As shown in Fig. 6 there is black ring, likely caused by graphitization from the electrons striking the stainless steel chamber. Black marks are also visible on the tops of the electron collector wedges, presumably due to electron impingement. However, the simulations do not explain all the damage to this bracket. There is also a vertical hole created in the bracket along the inner edge of the foil substrate (see the next section).

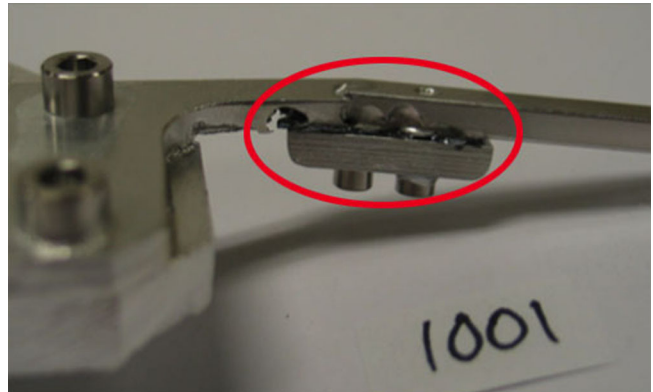
FIG. 7. A close-up view of the foil clamp for the bracket shown in Fig. 5. The ellipse indicates the damage caused by vacuum breakdown. (The figure was reproduced from Ref. [13].)

was clamped to the bracket. One hole passes completely through the bracket arm. The top of the bracket also shows similar material erosion at locations where the foil substrate had sharp edges that helped initiate the vacuum breakdown events.

good as aluminum due to its higher atomic number. The bracket and clamp were machined flat, and before clamping the foil to the bracket, both the bracket arm and the clamp were carefully polished to remove any sharp points that could contribute to cathode-spot in-vacuum breakdown. Some of the foils we installed in September 2009 were also sandwiched between layers of gold foil ~ 0.025 mm thick to help improve the large-area electrical contact between the foil and the bracket. The foils were also moved 1 cm further out on the arms of the brackets to improve the clearance for the circulating convoy electrons, and the arms and legs of the brackets were made as short as possible to remove any excess material that could be struck by beam halo or reflected convoy electrons. (Note that some additional length would need to be added to both the arm and the leg in order to mount fiber-supported foils.) The foil itself was modified to have a longer freestanding length, increased from 25 mm to 30–35 mm (i.e. shorter silicon substrate), to prevent beam halo and reflected convoy electrons from striking the substrate.

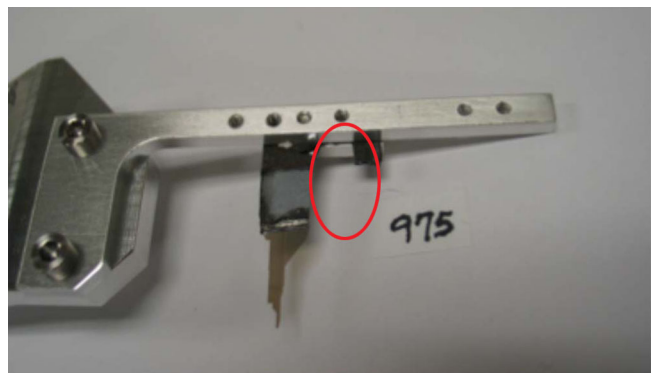
FIG. 8. An example of a fractured foil substrate on a third-generation foil bracket. The ellipse indicates the area where the substrate fractured and pieces fell off.

titanium. The clamping of the substrate to the holder in combination with the expansion of the holder induces significant tensile and compressive stresses in the silicon substrate. This can cause the silicon to fracture, which can then lead to rips and tears in the freestanding portion of the foil, and also create sharp edges that contribute to the vacuum breakdown. Some of the failed foils exhibited this symptom, such as the one shown in Fig. 8, where most of the right half of the silicon substrate is missing.

During the summer of 2009 several modifications were made to the foil and the bracket. The bracket material was changed from aluminum to titanium, since the thermal expansion coefficient of titanium is much better matched to that of silicon. Also titanium has a relatively high melting point, good electrical conductivity, and it is lightweight. However, the radioactivation properties are not as

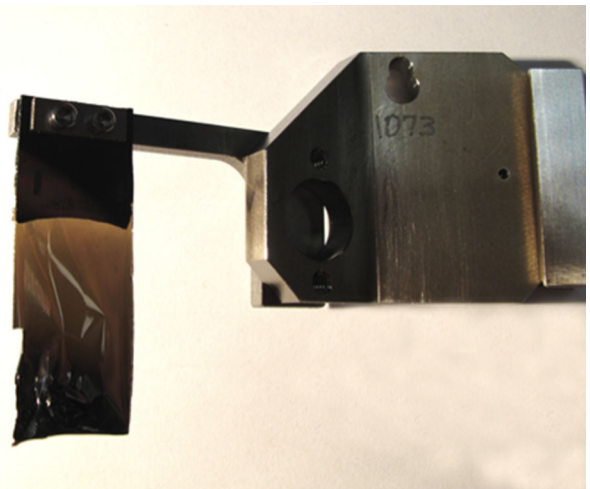
A new set of foils, half with the gold foil mounting and half without, were installed for the September to December 2009 run cycle. The first foil selected was one with the gold foil mounting method, and it lasted the entire run cycle, even after increasing the beam power to 1 MW. The total charge delivered to the target using this foil was 4820 C, to be compared to the previous high-power record of 978 C. The used bracket shows no signs of damage. The foil itself is blackened, twisted, and wrinkled, but it was still performing well at the end of the run cycle. A photograph of this foil and bracket, taken after it was removed in February 2010, is shown in Fig. 9.

FIG. 9. Photo of the fourth generation foil and bracket that lasted the entire September to December 2009 run cycle at high beam power. (The figure was reproduced from Ref. [13].)
