Surface investigation on prototype cavities for the European X-ray Free Electron Laser

The accelerating gradient Eacc of X-ray Free Electron Laser (XFEL) prototype cavities manufactured at the industry and treated at DESY demonstrates wide-range scattering from 15 to 41 MV/m. Most cavities satisfy the XFEL specification. Few cavities with low performance (15–17 MV/m) are limited by quench without field emission. The T-map analysis detected quench areas mainly close to the equator. Optical control by a high resolution camera has been applied and allowed to monitor the defects in some cases with good correlation to T-map observation. In order to understand the cause of reduced performance and get more detailed information of the origin of defects, some samples have been extracted from two cavities and investigated by light microscope, digital light microscope with 3D profile measurement, scanning electron microscope SEM, energy dispersive x-ray analysis, and Auger spectroscopy. The electron backscattered diffraction method in a SEM is used to make localized measurements of the lattice curvature. Several surface flaws with sizes from a few μm to hundreds of μm detected by microscopy.

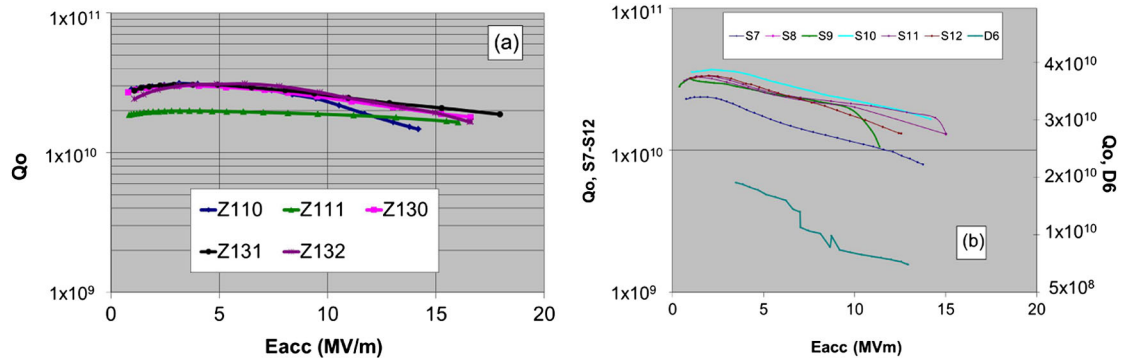
The main task of this work was concentrated on five cavities (Z110-Z111, Z130-Z132), produced by one vendor, that have an Eacc below 20 MV/m. As can be seen in Fig. 1(a), the $Q_0(\text{Eacc})$ behavior of these cavities seems to be similar: rather small change of Q_0 between 5–15 MV/m and after that a quench at 15–17 MV/m. Four cavities were treated by final EP and only one cavity (Z111) had the flash BCP final treatment. One of the cavities (Z110) was subjected to the attempt to improve performance by post-purification with titanium by annealing at 1400°C for 4 hours and subsequent BCP of approximately 100 μm . Unfortunately, this did not lead to an improvement of the accelerating gradient.

In the past 15 years of cavity production for TESLA Test Facility (FLASH), a case of failure by the fabrication resulted in a sequence of six cavities (S7-S12) with reduced performance [Fig. 1(b)]. Thorough analysis at that time together with the company allowed one to find out that after local grinding the surface was not sufficiently cleaned

FIG. 1. (a) Cavities of XFEL prototype manufactured with Eacc below 20 MV/m; (b) cavities S7-S12 and D6 of the 1st generation of FLASH fabrication.

It is interesting that two series of cavities with reduced performance demonstrate comparable behavior [Figs. 1(a) and 1(b)]. The contaminated cavities S7-S12 exhibit a bit more steep Q reduction. In both cases Eacc is limited by a strong quench below 20 MV/m.

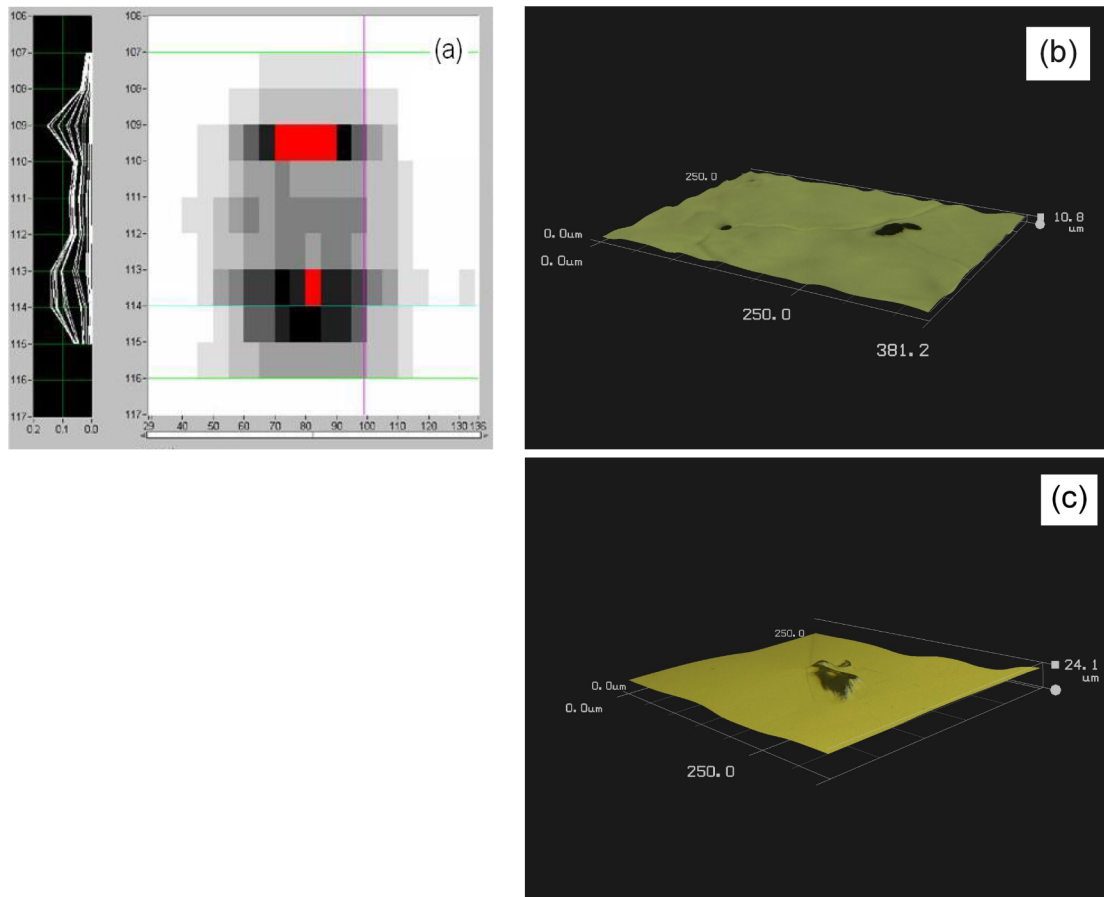
Some examples of the foreign material inclusions can be seen below. Many surface inclusions with sizes from a few μm to hundreds of μm were detected by SEM on two samples separated from cell 1 of the cavity Z130 [Figs. 3(a)–3(c)]. One inclusion indicates increased content of iron [Figs. 4(a) and 4(b)].

FIG. 3. (a) T-map for π mode with hot spots in the equator area of cavity Z130 and away from the equator caused quench at 16 MV/m; (b), (c) images of defects detected in the hot-spot areas shown in (a).

surface [Fig. 3(b) upper image, for example] and do not stick in, but more precise analysis shows that the material of the black spots adheres to the surface [Fig. 3(c) beneath].

More difficult to explain is the cause of the black spots as shown in Figs. 3 and 5–7. The Auger spectra indicate attendants of hydrocarbons. On one hand, a lot of hydrocarbons surround the electron beam welding (EBW) procedure (not sufficient part degreasing, oil fractions from the diffusion pump, rest of oils on the wall of the EBW chamber, etc.). At the same time it is difficult to imagine, even if the surface were contaminated, how the contaminants could survive after the subsequent treatment including removal of the surface layer of 150 μm thick. On the other hand, a lot of hydrocarbon-based material is used into treatment procedure too (polymers, alcohols, etc.) which (if remains on the surface) can adhere during 800°C annealing. Final EP removes these remainders possibly less efficiently compared to BCP flash. Suspicion of this could perhaps explain why the bad cavities were mainly EP treated in the end. From this point of view, the corrosion holes in Z111 can be considered as the residues remaining after etching away of the black spots by BCP.

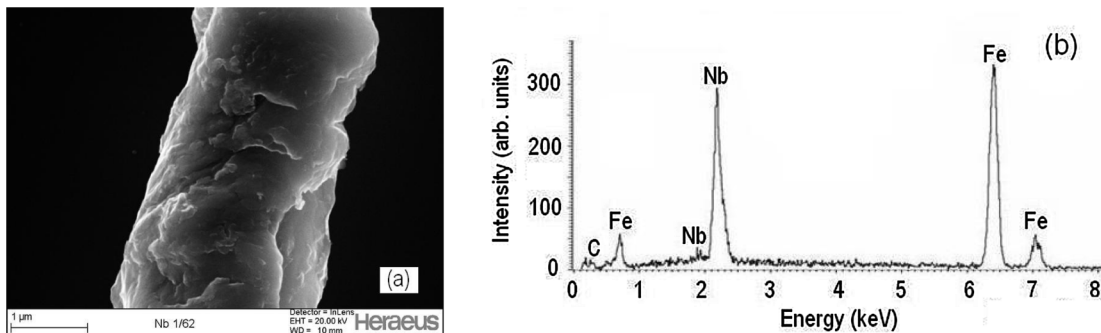
FIG. 4. (a) SEM image of the foreign material inclusion; (b) EDX element analysis of the image of (a).

For example, it could be highly probably supposed that embedding of iron particles happened during deep drawing or handling of subassembly parts at the factory. Particles were already present during EP treatment; the surface of the particles is smooth as usual after EP. On the other hand, they were not present in the niobium sheet. The sheets were provided to the vendor after eddy current scanning [2]. Iron, as a magnetic material, contributed significantly to eddy current signal and definitely would be detected.

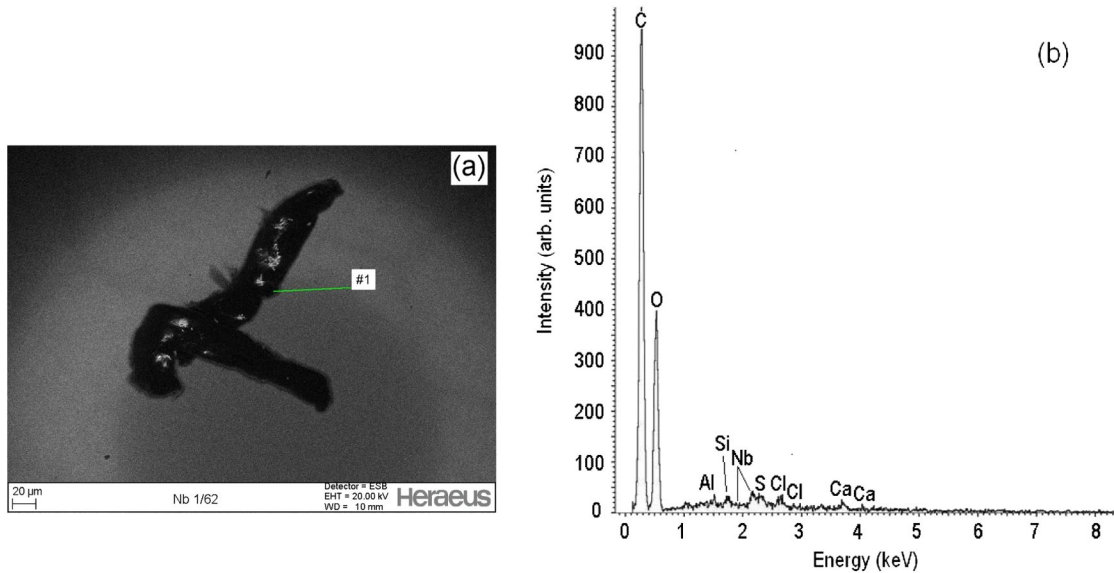
Most inclusions indicate increased content of carbon. Some inclusions indicate increased content of oxygen as well as carbon [see, for example, Fig. 5(a) and 5(b)].

FIG. 5. (a) SEM image of the black spot represented in Fig. 3(b); (b) EDX element analysis of the black spot represented by (a).

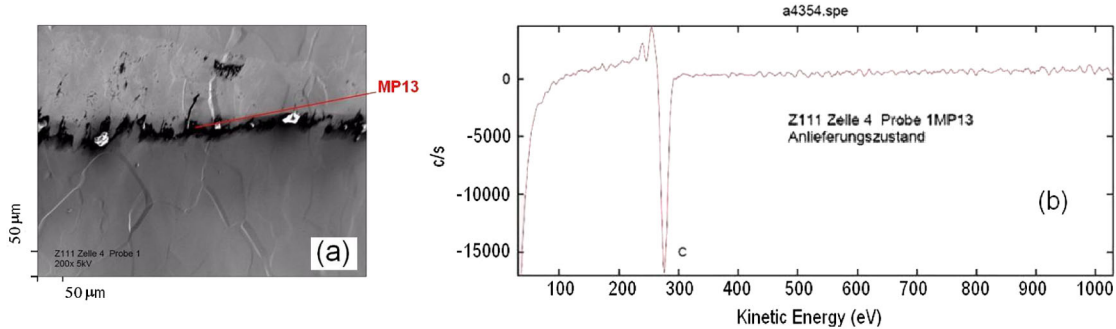
Similar black spots of different shapes have been observed in the cavity Z111 too [see, for example, Fig. 6(a)]. At first glance it seems that the black spots lie on the

One of the black areas [see image in the Fig. 6(a)] with pronounced carbon signal in the Auger spectrum [Fig. 6(b)] was removed by ion sputtering. The black spot and the carbon signal disappeared only after many cycles of sputtering and removal of a layer of 500 nm [Figs. 7(a) and 7(b)].

FIG. 6. (a) Area of black spots detected in the cavity Z111; (b) Auger spectrum of the black spots of (a) indicating the presence of carbon.

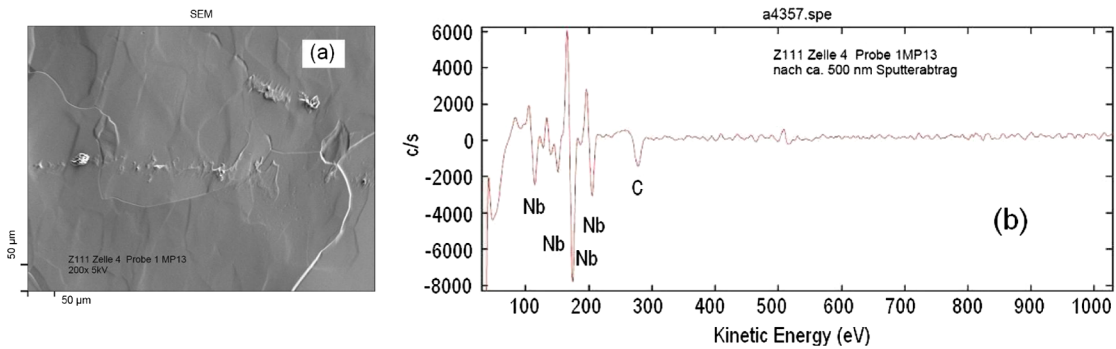
FIG. 7. (a) Area shown in Fig. 6(a), but after ion sputtering and removal of the layer of 500 nm; (b) Auger spectrum of the area shown in (a) (conventional spectrum of pure niobium).

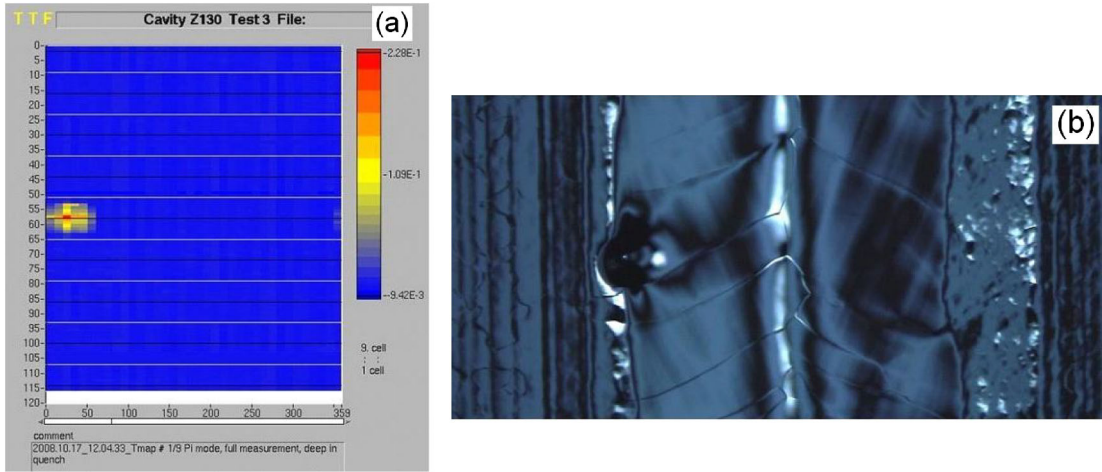
Figure 8(a) shows the T-map for $(3/9)$ π mode excitation. Quench at 23, 3 MV/m was found in cell 5 of

the cavity Z130. Optical inspection done on the cavity by the high resolution camera in use at DESY discovered a topographical defect of 1 mm size on the interface between the welding seam and heat-affected zone [Fig. 8(b)]. The defect area was studied more carefully

FIG. 8. (a) T-map for $(3/9)$ π mode excitation of the cavity Z130; (b) optical inspection image of the hot spot represented in (a).

The topological defect presented in Figs. 8 and 9 seemingly could be caused at the factory presumably as a result of not sufficient removal of the flake after machining; or imprecise clamping, or possibly a welding error in this location.

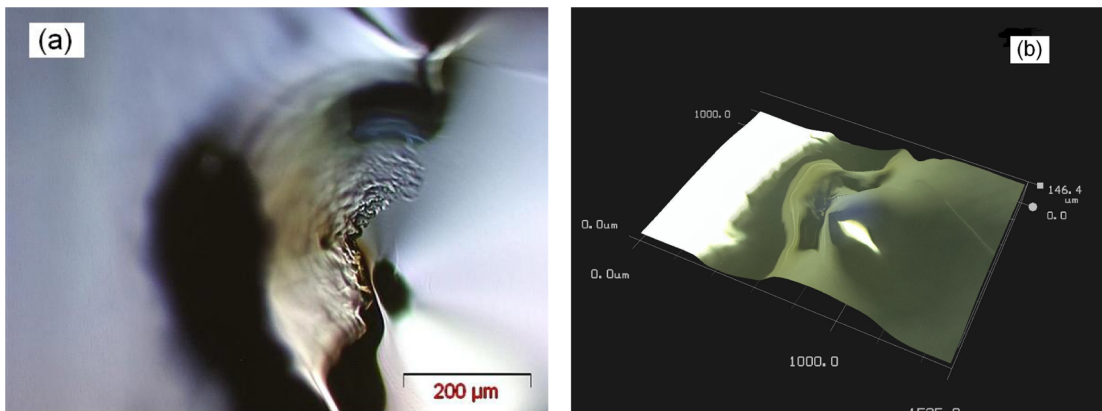
on the separated sample. No foreign material was monitored. The topography of the defect with a big distance between the peak and the valley (more than 150 μm) can be seen on images of light and 3D microscopes [Figs. 9(a) and 9(b)].

FIG. 9. (a) Light microscope image of the hot spot represented in Fig. 8(a); (b) 3D microscope image of the hot spot represented in Fig. 8(a).

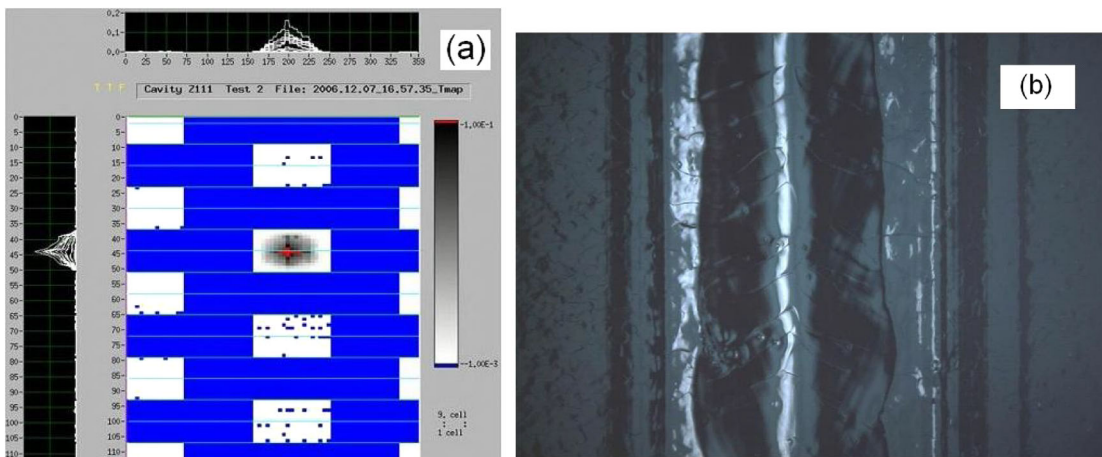
Another topographical defect that limited the accelerating gradient by quench at 16 MV/m was detected in cell 6 of cavity Z111 on the equator weld. A group of beads of 1.5 mm width were observed

in the heating location [Fig. 10(a)] by optical inspection [Fig. 10(b)].

FIG. 10. (a) T-map of cavity Z111; (b) high resolution camera inspection of the hot spot of (a).

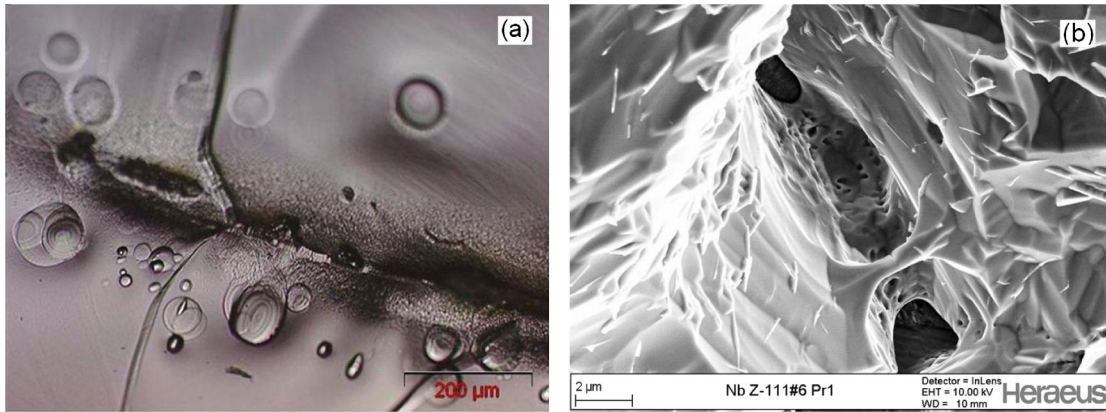
FIG. 11. (a) Light microscope image of the hot spot represented in Fig. 10(a); (b) magnified SEM image of holes represented in (a).

along a grain boundary were clearly visible in the light microscope image [Fig. 11(a)]. Smaller holes inside of the bigger hole were detected by high SEM resolution [Fig. 11(b)]. The impression gained was that of local corrosion taking place in this area. Several etching pits were positioned around corrosion holes.

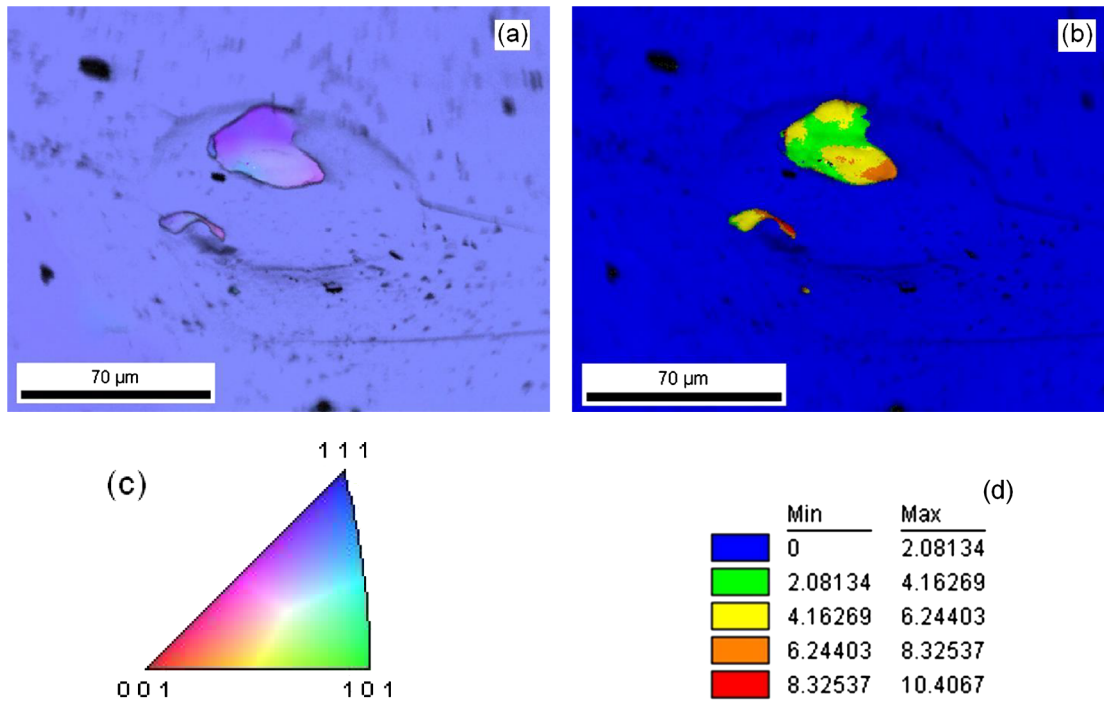
Figure 12 shows the results from a pit near the HAZ of an equator weld. The pit encloses a region of high strain (high dislocation density). This is evident in the color change of the IPF map and in the GROD map. The GROD map indicates a lattice rotation rate of $3^\circ/\mu\text{m}$ within the pit in the absence of any grain boundaries. The pit was within a grain with a surface near the (111) plane.

FIG. 12. SEM and EBSD results from pit near the HAZ, sample #2. ($200 \times 200 \mu\text{m}$, $0.5 \mu\text{m}$ resolution): (a) inverse pole figure (pit near [111]); (b) GROD map; (c) key for (a); (d) key for (b). Maximum lattice rotation rate within pit of $3^\circ/\mu\text{m}$.

Pits from different regions of the cavity interior surface were compared for orientation of the grain face plane, for lattice curvature within the pit, and for lattice curvature nearby the pit. Pits near the equator weld HAZ tended to be located near regions of high lattice curvature rate,

indicative of high stored strain energy. They were found on (111) surface planes, within individual grain.

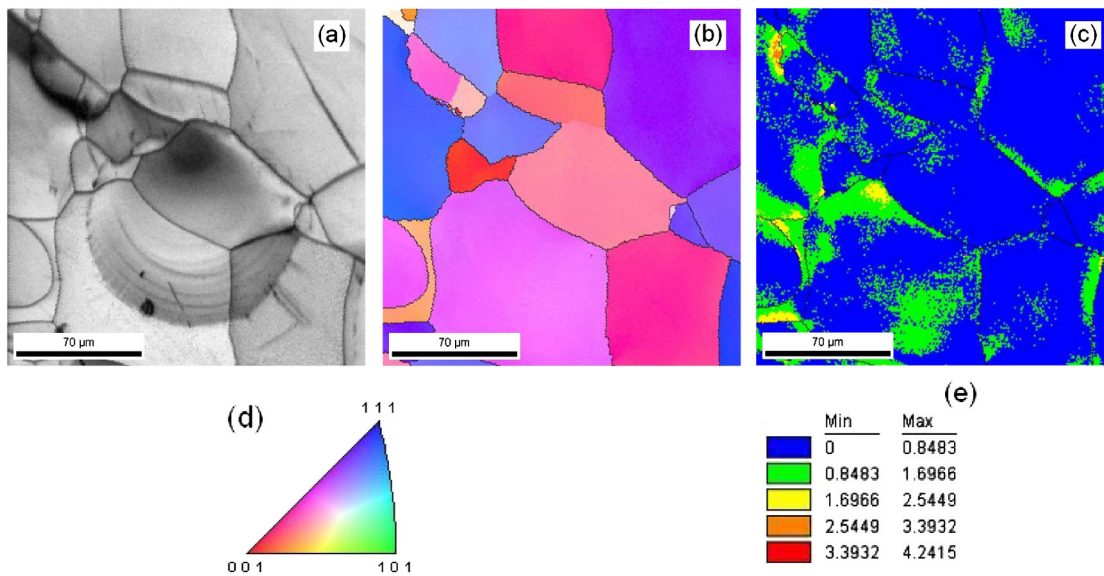
The pit shown on Fig. 12 was not near high strain areas but from a grain surface near (111). Another sample shows a grain surface near (001). A larger area scan was done in an attempt to locate any high strain areas near the pit. The pit was on a near (001) grain surface without any nearby strain (Fig. 13).

FIG. 13. SEM and EBSD results from pit far from the HAZ, sample #4. ($200 \times 200 \mu\text{m}$, $1 \mu\text{m}$ resolution): (a) image quality map; (b) inverse pole figure (pit near [001]); (c) GROD map; (d) key for (b); (e) key for (c). Maximum lattice rotation rate within pit of $\sim 0.2^\circ/\mu\text{m}$. Note “beach” markings.

Pits far from the HAZ tended to occur on grain boundary triple junctions. They were found on both (111) and (001) grain surfaces. Although these pits appeared to be of the same geometry as the HAZ pits, they included peripheral “beach markings” near the edge of the pits. The “beach markings” were not observed on the HAZ pits. The “beach markings” suggest a progressive chemical reaction associated with the pit formation, or a process which occurs during evaporation of a liquid solution.

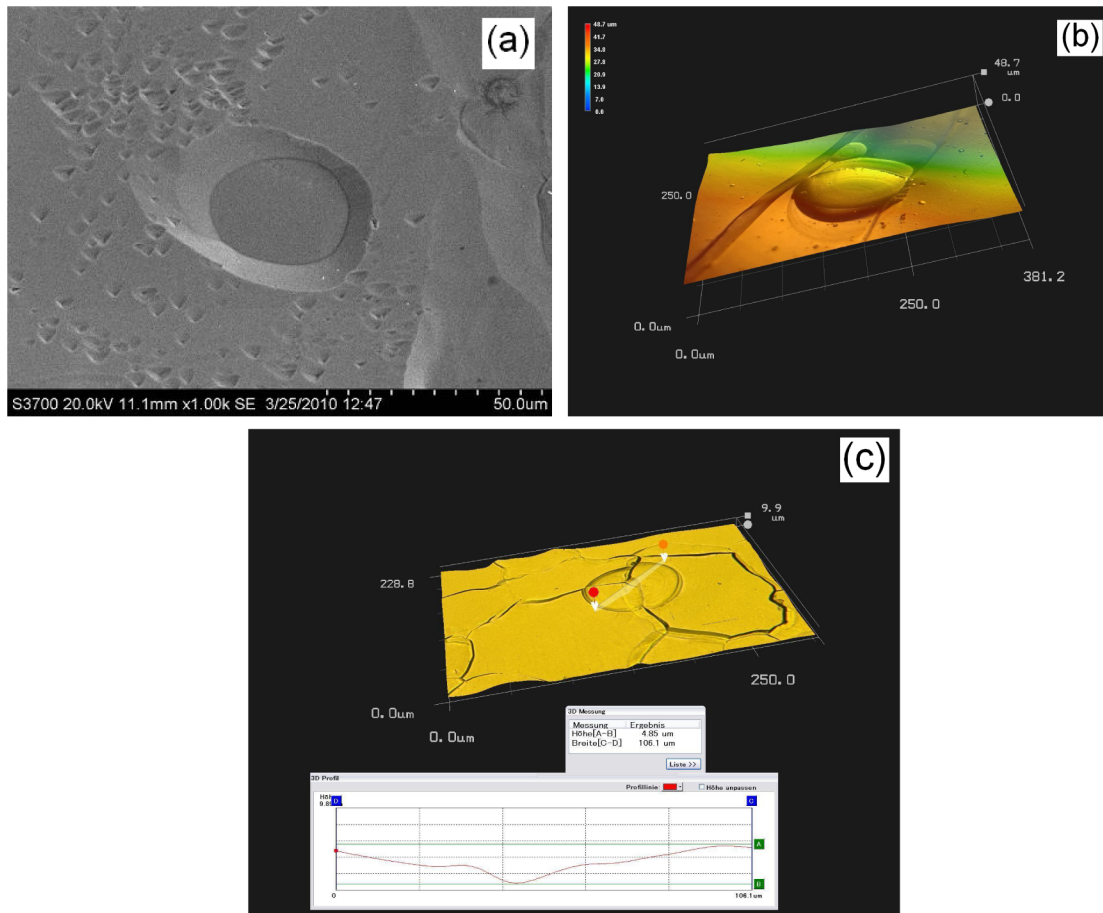
The results describing the pit morphology are shown in Figs. 14(a)–14(c). The examined pits were shallow (the depth of the pits lay in the region of $5\text{--}20 \mu\text{m}$) and had a flat bottom. The pit walls were mostly tapered.

FIG. 14. Examples of images and depth profiles of pits. Pits are shallow and flat.

The pits in the studied samples from BCP flash treated cavity were shallow and flat. It should be noted that this is
