Breakdown study based on direct *in situ* observation of inner surfaces of an rf accelerating cavity during a high-gradient test

Tetsuo Abe,* Tatsuya Kageyama, Hiroshi Sakai, Yasunao Takeuchi, and Kazuo Yoshino
*Accelerator Laboratory, High Energy Accelerator Research Organization (KEK),
 Tsukuba, Ibaraki 305-0801, Japan*

DOI: 10.1103/PhysRevAccelBeams.19.102001

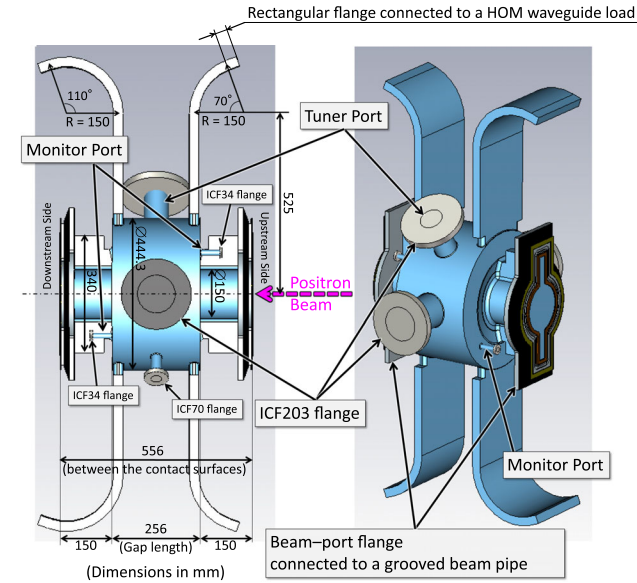
(a) Conceptual diagram of the DR cavity. The blue region is a vacuum during high-gradient operation. The gap length and diameter of this cavity are 256 and 444.3 mm, respectively.

Figure 1(a) shows a conceptual diagram of the DR cavity, which is a pillbox cavity of a single cell used to excite a continuous TM_{010} standing wave as the accelerating mode. The accelerating voltage per cavity [cavity voltage (V_c)] during DR operation is 0.70 MV and has an equivalent accelerating gradient (E_{acc}) of 2.7 MV/m. This cavity voltage is comparable to actual operating voltages of other accelerating cavities of the

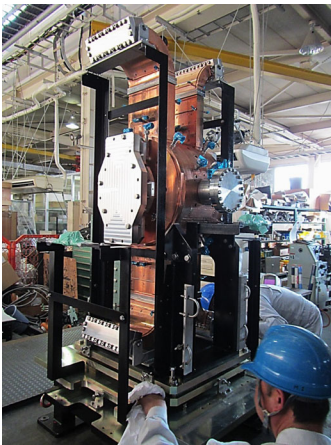
(b) DR cavity No. 2 immediately after its delivery.

structure, and were made using the same fabrication method. Figure 1(b) is a photograph of DR cavity No. 2 immediately after its delivery. This paper presents results of a breakdown study of this cavity through high-gradient testing.

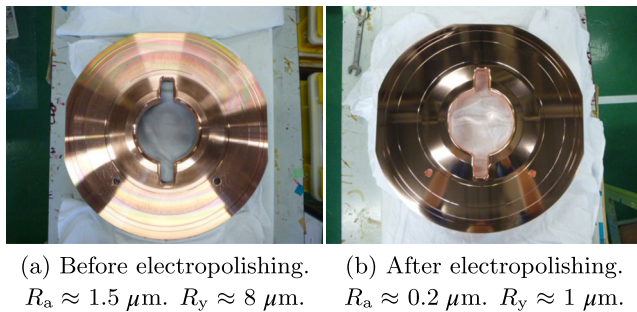
FIG. 2. Photographs of the end plate (a) before and (b) after electropolishing with approximately 40 μm of etching. The outer diameter is approximately 500 mm. The inner diameter of the beam port is 150 mm.

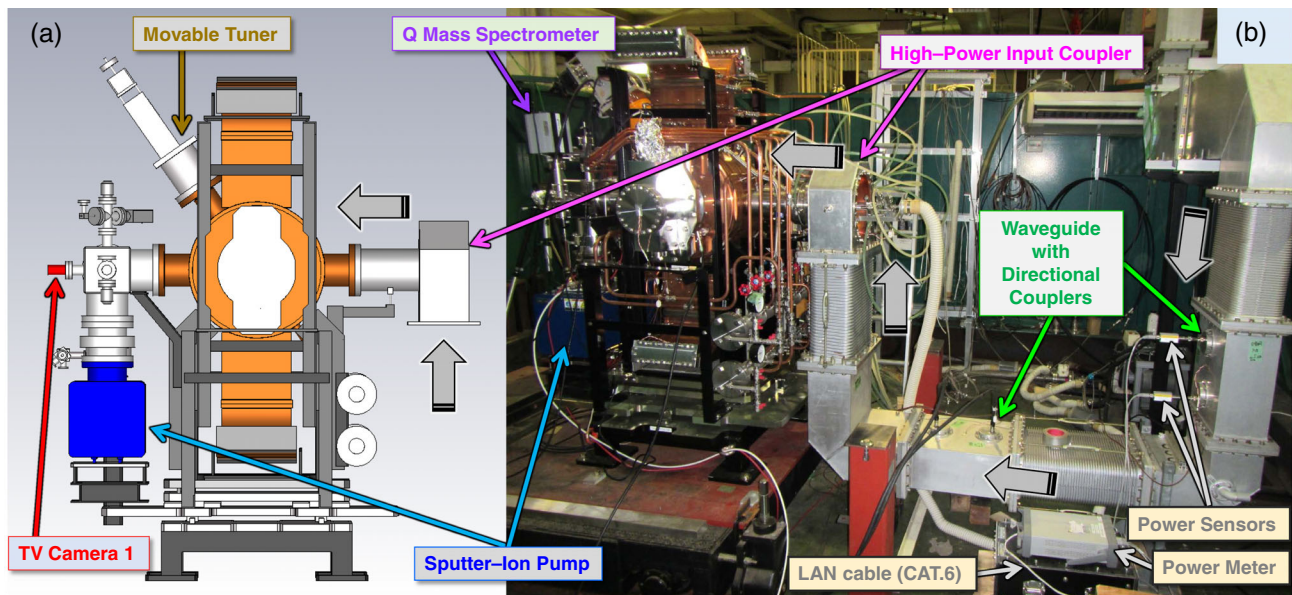
FIG. 3. (a) Diagram of DR cavity No. 2. (b) Photograph of the test stand used for the high-gradient test of DR cavity No. 2 in a radiation-controlled area. The bold arrows indicate the flow of high rf power generated by a 1.2-MW continuous-wave klystron. The klystron is not included in this photograph. The turbo-molecular pump is behind the sputter-ion pump.

The setup of the high-gradient test for DR cavity No. 2 is shown in Fig. 3. We used a 1.2-MW continuous-wave klystron as a high-power source together with a four-port circulator to protect this klystron. High rf power was fed into the cavity through a coaxial-type high-power input coupler. The input coupler has fine grooves on the outer conductor of the coaxial line to suppress multipactoring [18]. The coupling factor of the input coupler was set to 1.3 at low rf power by adjusting its coupling loop angle.

sensors connected directly to the directional coupler near the cavity, as shown in Fig. 3(b).

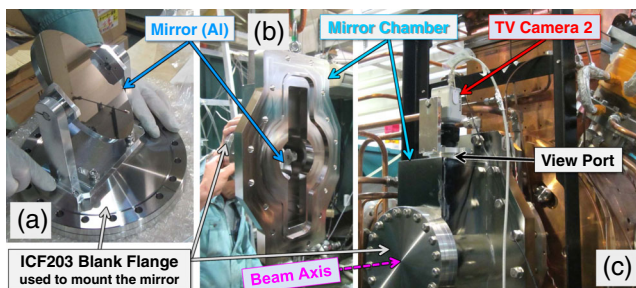
FIG. 4. Mirror chamber used for the high-gradient test of DR cavity No. 2. (a) Aluminum elliptical mirror mounted on an ICF203 blank flange. The surface was finished by lapping, yielding $R_a \approx 1$ nm. (b) Stainless steel vacuum chamber containing the mirror. The inner surface of this chamber was electropolished. (c) Mirror chamber attached to DR cavity No. 2.

To implement the direct observation method, we fabricated two vacuum chambers containing mirrors (mirror chambers) and used them in this high-gradient test, as shown in Fig. 4. Near the beam axis, the radiation level is high during high-gradient operation; therefore, a mirror is located inside the mirror chamber to allow the observation of the inside of the cavity through the beam port. We attached a television (TV) camera with a charge-coupled device sensor to the view port of the mirror chamber far from the beam axis, as shown in Fig. 4(c). For DR cavity No. 1, we attached only one mirror chamber, which contained a circular mirror, to the upstream beam port [17], whereas for DR cavity No. 2, we attached two mirror chambers, each of which contained an elliptical mirror, to the upstream and downstream beam ports to obtain a wider

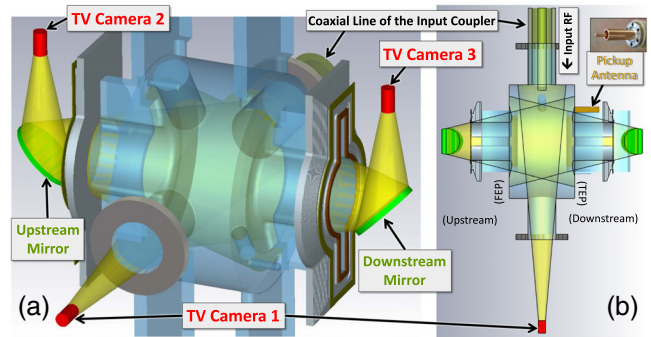
FIG. 5. (a) Schematic of the experimental devices. Red cylinders and yellow regions represent the three TV cameras and their fields of view, respectively. During the high-gradient test, the inside of the cavity (blue) was a vacuum, and the mirrors (green) were contained in the mirror chambers, as shown in Fig. 4. (b) Cross section along the horizontal plane including the center of the cavity.

view. In total, we used three TV cameras for the multidirectional and wide-field observation of the inside of the cavity, as shown in Fig. 5. TV camera 1 was attached to the viewport of the vacuum evacuation system on the side

opposite the input coupler. TV camera 2 was attached to the upstream beam port and aimed toward the downstream end plate (the TEP). TV camera 3 was attached to the downstream beam port and aimed toward the upstream end plate (the FEP). Note that we use the words “upstream” and “downstream” for convenience; no beam was injected into the cavity during this high-gradient test.

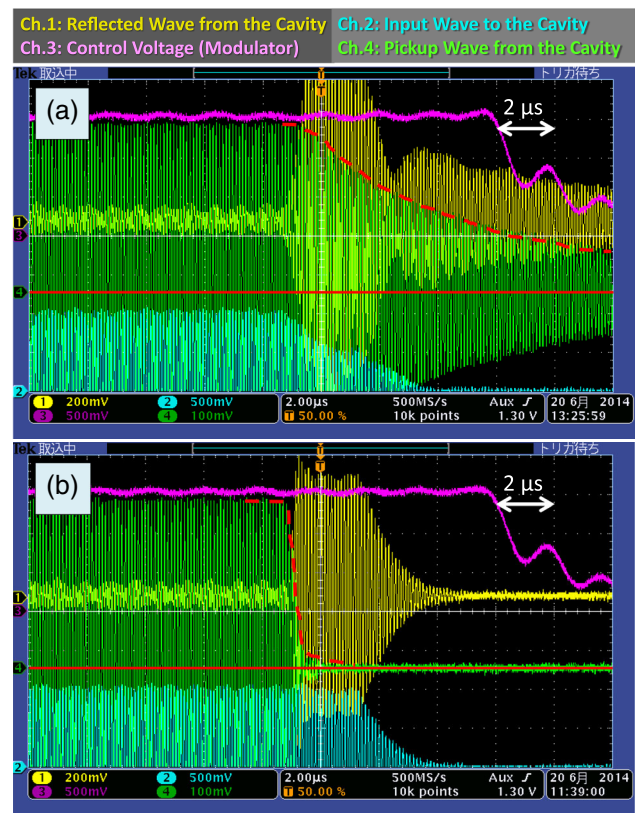
FIG. 6. Waveforms of the oscilloscope displayed for a time span of 20 μ s ($=2 \mu$ s/div) when the interlock system was activated. The red dashed curves show the envelope of the 508.9-MHz pickup signal from DR cavity No. 2, and the red solid lines show the zero level. (a) Waveforms when the rf switch was turned off for a reason related to the klystron. (b) Example of cavity breakdown events.

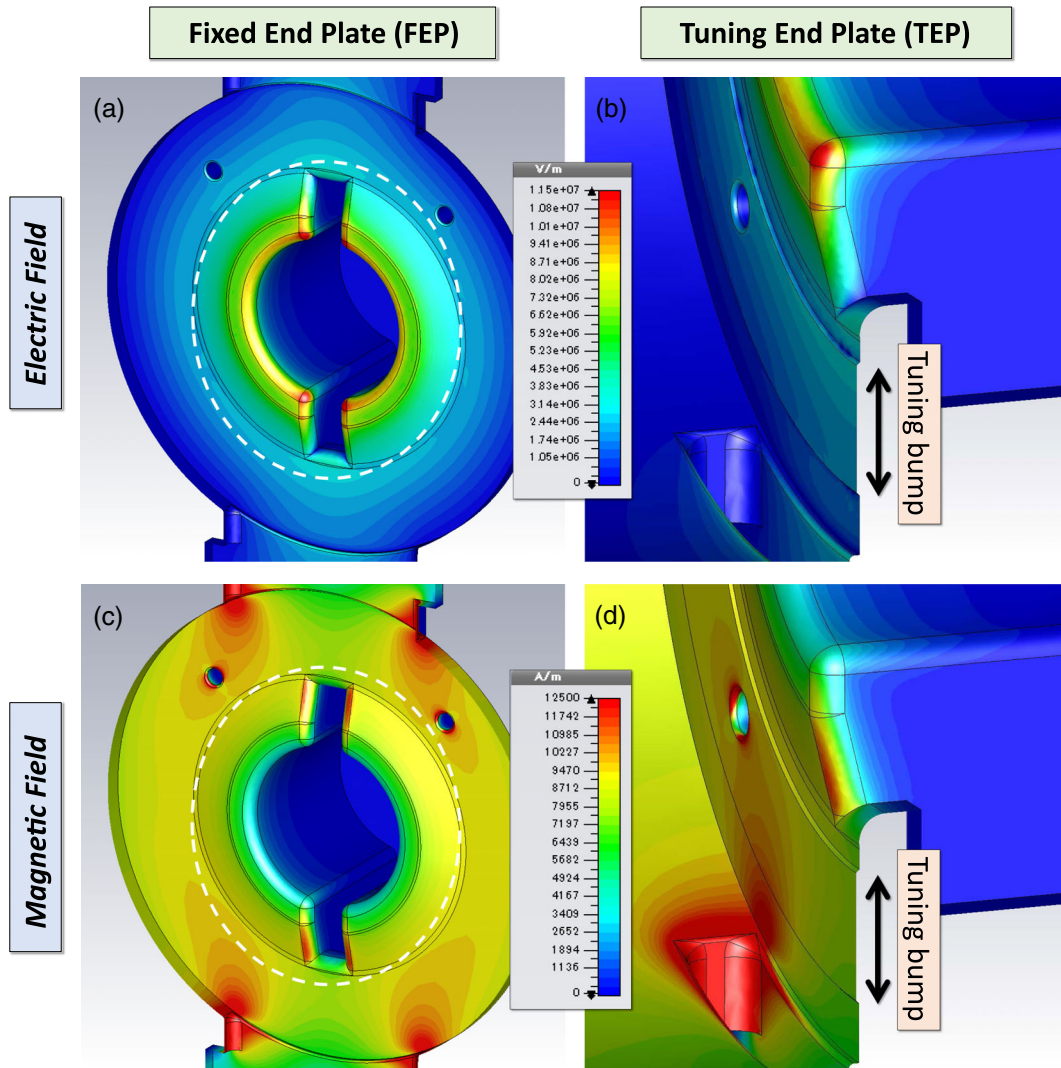
FIG. 8. Surface field of the accelerating mode at $V_c = 0.90$ MV ($E_{acc} = 3.5$ MV/m). The region inside the white dashed ellipse on the FEP was observable with TV camera 3, and the observable region on the TEP was almost the same. The maximum strengths of the electric and magnetic fields are 13 MV/m on the nose cone and 34 kA/m at the aperture for the HOM waveguide, respectively. (a) Electric field on the FEP. (b) Electric field on the TEP with a vertical cut plane. (c) Magnetic field on the FEP. (d) Magnetic field on the TEP with a vertical cut plane.

As shown in Figs. 10 and 11, clear bright spots were observed on the end plates during high-gradient operation [19]. These bright spots maintained their intensity for hours or longer, and had no significant effects on the high-gradient operation as long as they remained stable. As shown in Figs. 12(c) and 14(f), any bright spot did not continue without rf power for more than a few tens of milliseconds. Currently, the origin of the bright spots is unknown; however, it is presumed that they could be caused by microscopic protrusions on the copper surface or small particles from outside of the cavity adhering to the copper surface. To reveal their origin, more information is required, including the spectra of the bright spots. It is also noteworthy that neither the density nor the intensity of the bright spots was found to have any clear correlation with the surface field strength (Fig. 8).

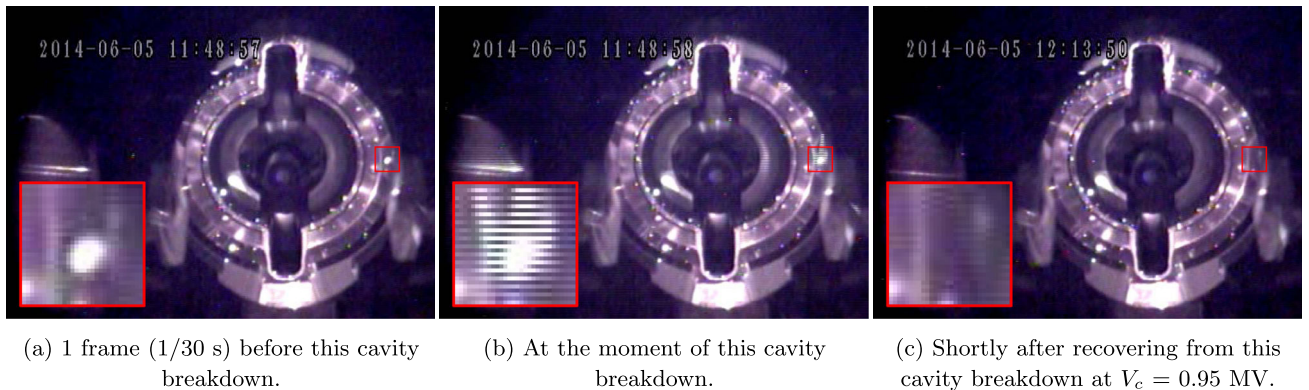
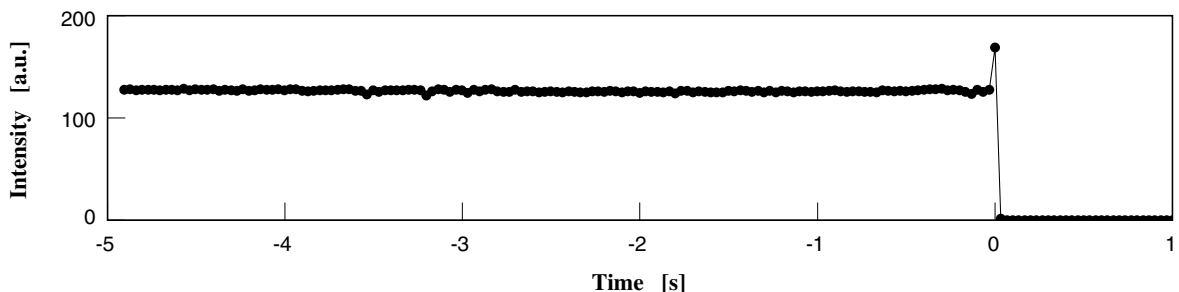
(d) Intensity of the pixels in the region inside the red square for each frame during the time period from 5 s before until 1 s after this cavity breakdown. The origin of the horizontal axis is the time at which this cavity breakdown occurred.

FIG. 9. Example of spot-type explosion events with a stable bright spot. (a), (b), and (c) are snapshots, in chronological order, of the FEP recorded with TV camera 3 during the rf conditioning. The insets are magnified views of the region outlined by a red square. The bright spot at 3 o’clock [inside the red square in (a)] exploded at $V_c = 0.95$ MV, as shown in (b), and then disappeared, as shown in (c). A clear spike was observed in the intensity of the region outlined by a red square at the moment of this cavity breakdown, as shown in (d).

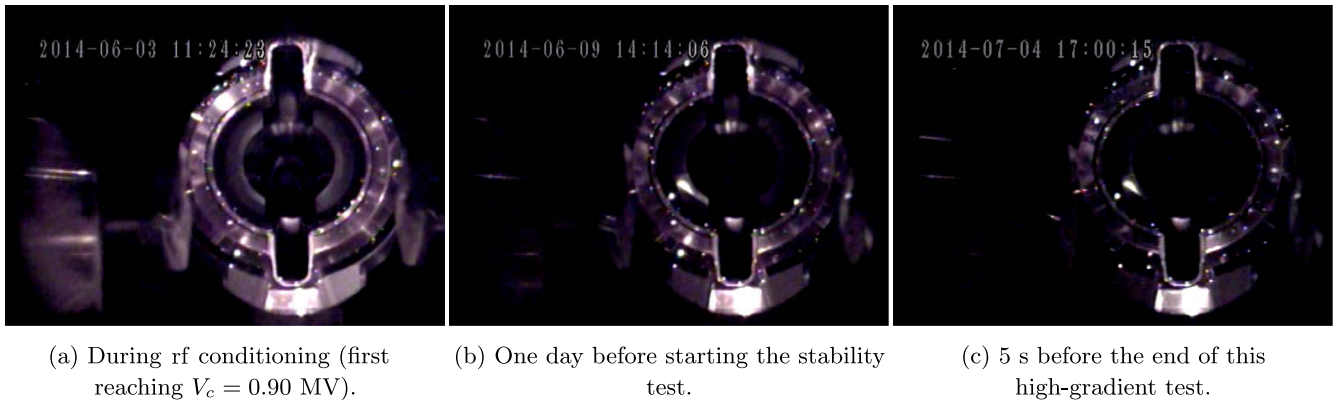
FIG. 10. Snapshots of the FEP recorded with TV camera 3 at $V_c = 0.90$ MV.

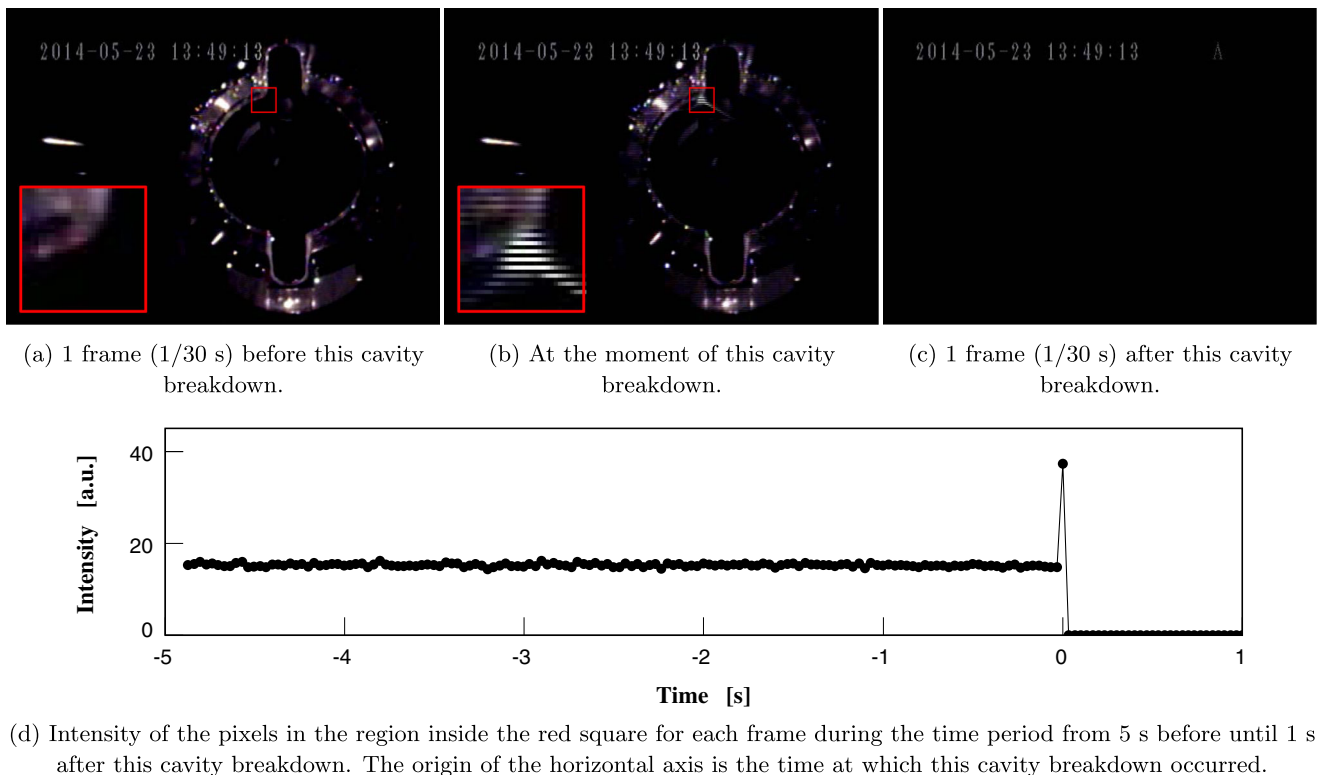
FIG. 12. Example of spot-type explosion events without a stable bright spot. (a), (b), and (c) are snapshots, in chronological order, of the FEP recorded with TV camera 3 during the rf conditioning. The insets are magnified views of the region outlined by a red square. A spot-type explosion occurred at 11 o'clock [inside the red square in (b)] at $V_c = 0.65$ MV; however, no bright spot was present in this region until one frame before this cavity breakdown, as indicated by the red square in (a). A clear spike was observed in the intensity of the region outlined by a red square at the moment of this cavity breakdown, as shown in (d).

In Table IV, an event classified as the “spot-type explosion not originating from a stable bright spot” column (hereafter, a spot-type explosion event without a stable bright spot) is defined as a cavity breakdown event accompanied by a spot-type explosion at the position where no stable bright spot was observed until 2 s before the cavity breakdown. Spot-type explosion events with and without a stable bright spot are hereafter collectively called spot-type explosion events. Figure 12 shows an example of spot-type explosion events without

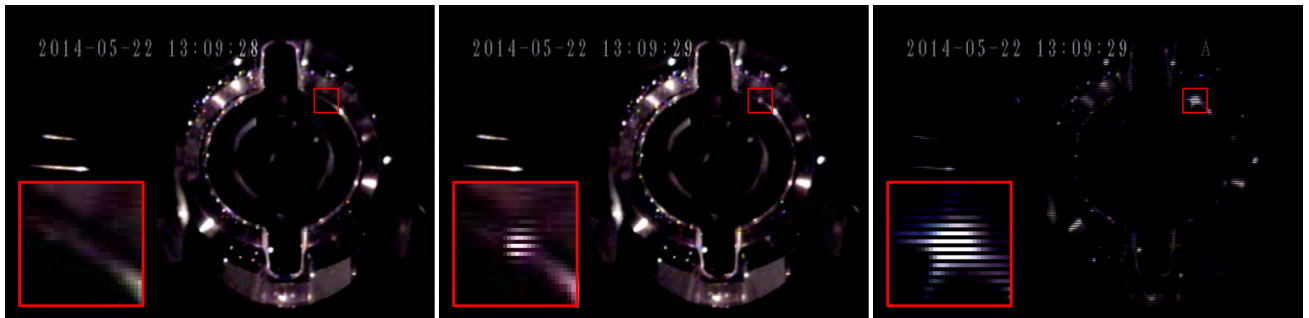
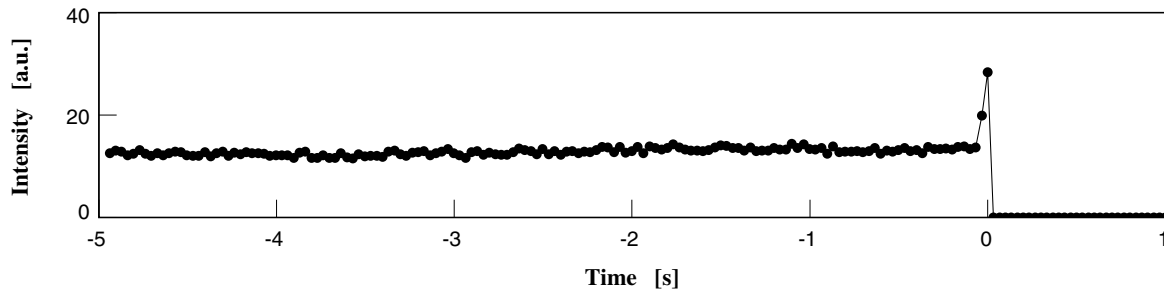
(d) Intensity of the pixels in the region inside the red square for each frame during the time period from 5 s before until 1 s after this cavity breakdown. The origin of the horizontal axis is the time at which this cavity breakdown occurred.

FIG. 13. Example of spot-type explosion events without a stable bright spot, accompanied by the sudden appearance of a new bright spot. (a), (b), and (c) are snapshots, in chronological order, of the FEP recorded with TV camera 3 during the rf conditioning. The insets are magnified views of the region outlined by a red square. There was an explosion at 1 o'clock [inside the red squares in (b) and (c)] at $V_c = 0.56$ MV; however, no bright spot was present in this region until 2 frames (2/30 s) before this cavity breakdown, as indicated by the red square in (a). A clear spike was observed in the intensity of the region outlined by a red square at the moment of this cavity breakdown for two frames, as shown in (d).

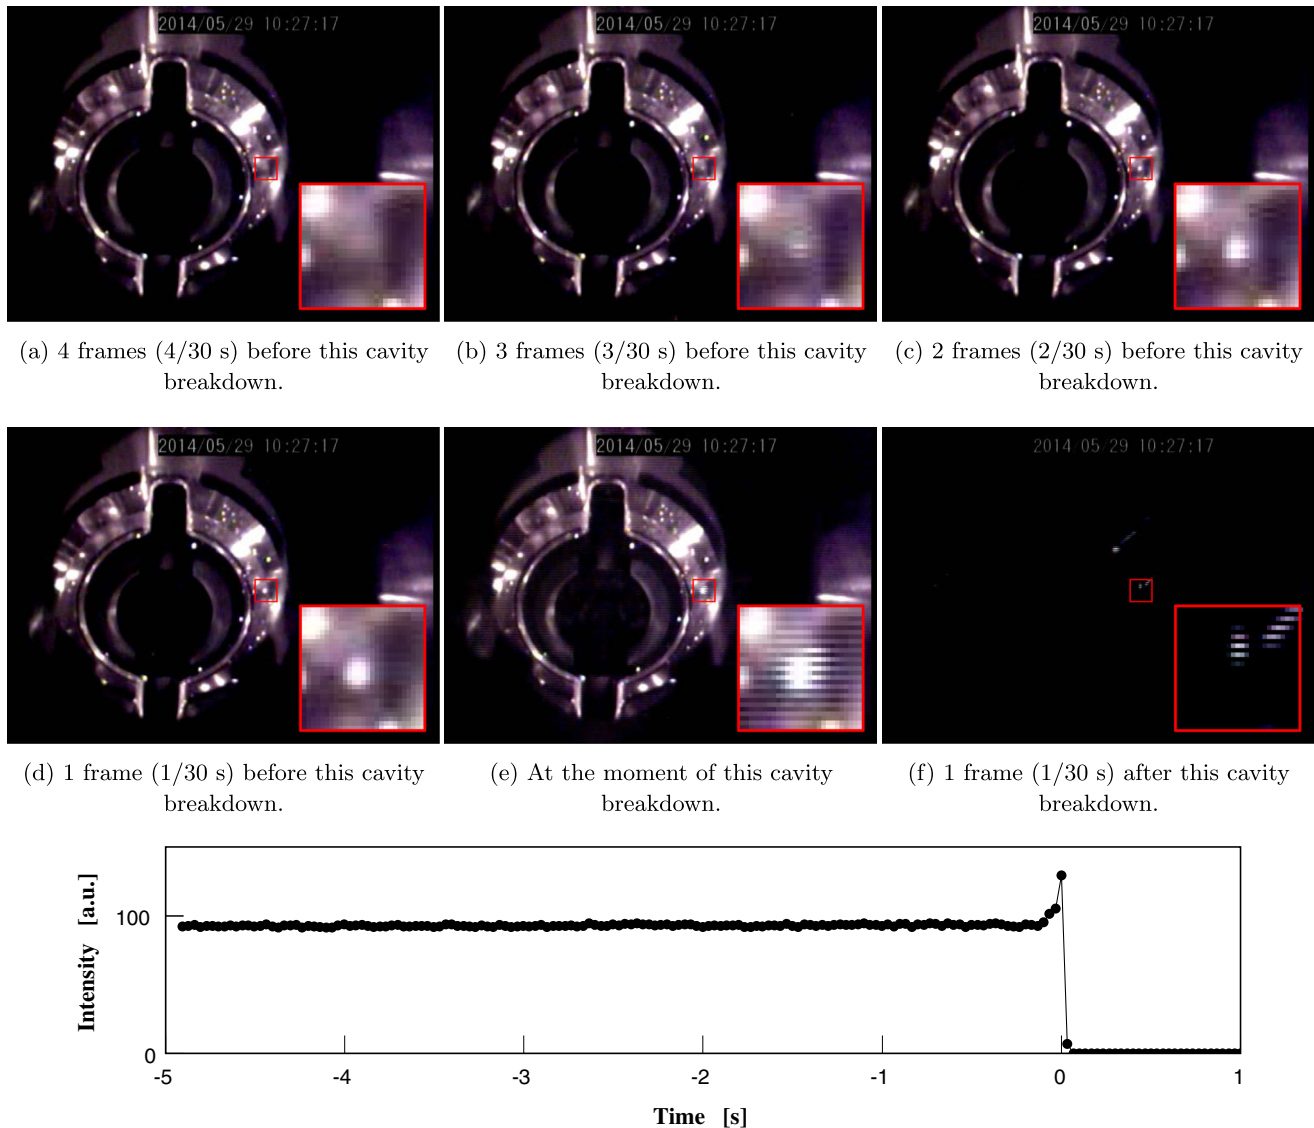
(g) Intensity of the pixels in the region inside the red square for each frame during the time period from 5 s before until 1 s after this cavity breakdown. The origin of the horizontal axis is the time at which this cavity breakdown occurred.

FIG. 14. Example of spot-type explosion events without a stable bright spot, accompanied by the sudden appearance of a new bright spot. (a)–(f) are snapshots, in chronological order, of the TEP recorded with TV camera 2 during the rf conditioning. The insets are magnified views of the region outlined by a red square. There was an explosion at 3 o’clock [indicated by the red square in (b)–(e)] at $V_c = 0.80$ MV; however, no clear bright spot was present in this region until 4 frames (4/30 s) before this cavity breakdown, as indicated by the red square in (a). A new small bright spot appeared in this region 3 frames (0.1 s) before this cavity breakdown, as indicated by the red square in (b). A clear spike was observed in the intensity of the region outlined by a red square at the moment of this cavity breakdown for four frames, as shown in (g).

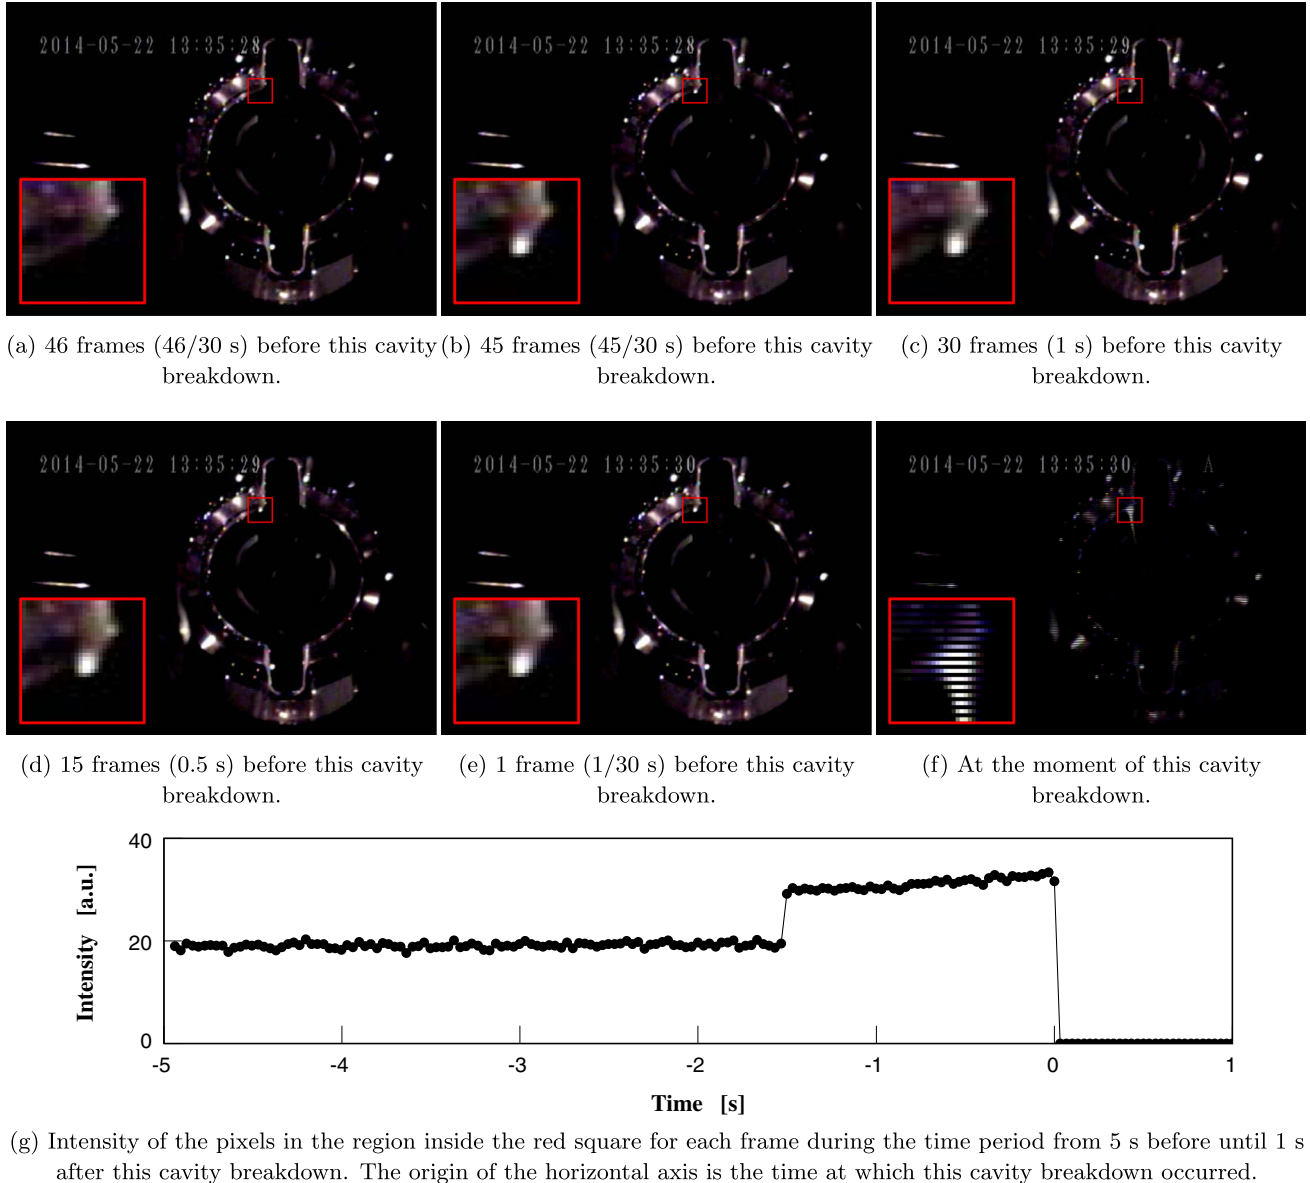
FIG. 15. Example of spot-type explosion events without a stable bright spot, accompanied by the sudden appearance of a new bright spot. (a)–(f) are snapshots, in chronological order, of the FEP recorded with TV camera 3 during the rf conditioning. The insets are magnified views of the region outlined by a red square. In this case, a new bright spot appeared at 11 o’clock 45 frames (1.5 s) before this cavity breakdown at $V_c = 0.54$ MV. A clear enhancement was observed in the intensity of the region outlined by a red square over the 46 frames, starting at the moment when the new bright spot appeared, as shown in (g).

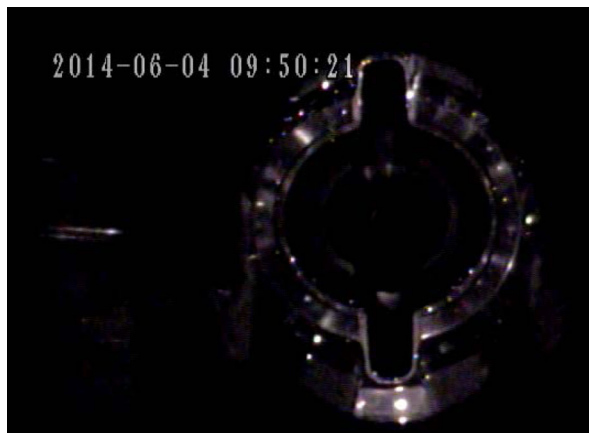
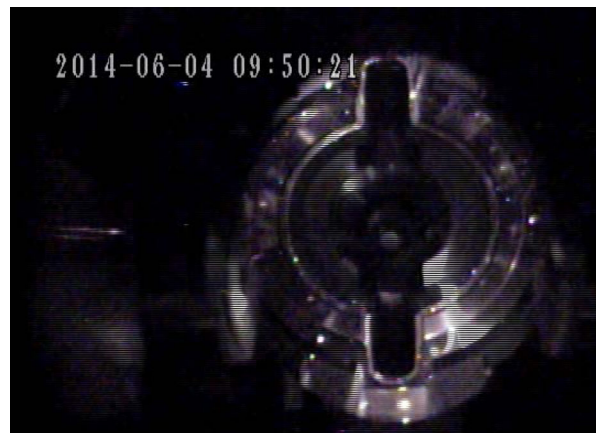
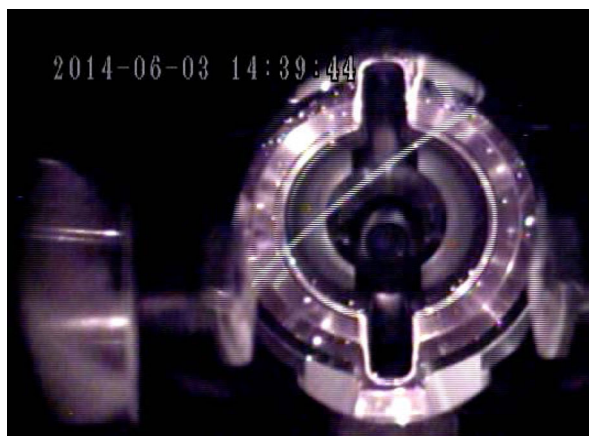
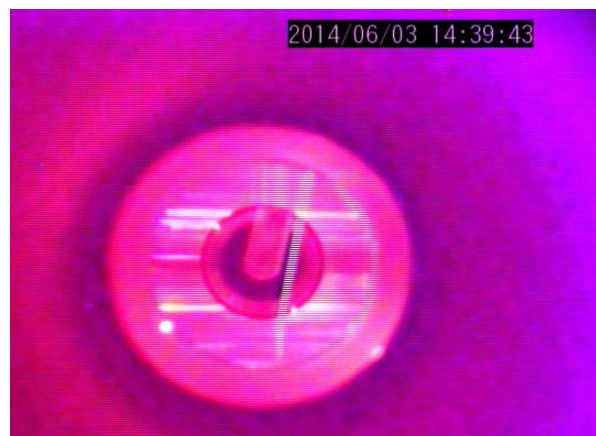
(a) 1 frame (1/30 s) before the cavity breakdown.

(b) Flash at the moment of the cavity breakdown.

(c) Lightning captured with TV camera 3.

(d) Lightning captured with TV camera 1.

FIG. 16. Examples of non-spot-type breakdown events. (a) and (b) Cavity breakdown event at $V_c = 0.76$ MV accompanied by a flash. This event is included in the “Non-spot-type flash” column in Table IV. (c) and (d) Snapshots 2/30 s before a cavity breakdown at $V_c = 0.90$ MV accompanied only by lightning. No other phenomena were observed. This event is included in the “Non-spot-type lightning only” column in Table IV.

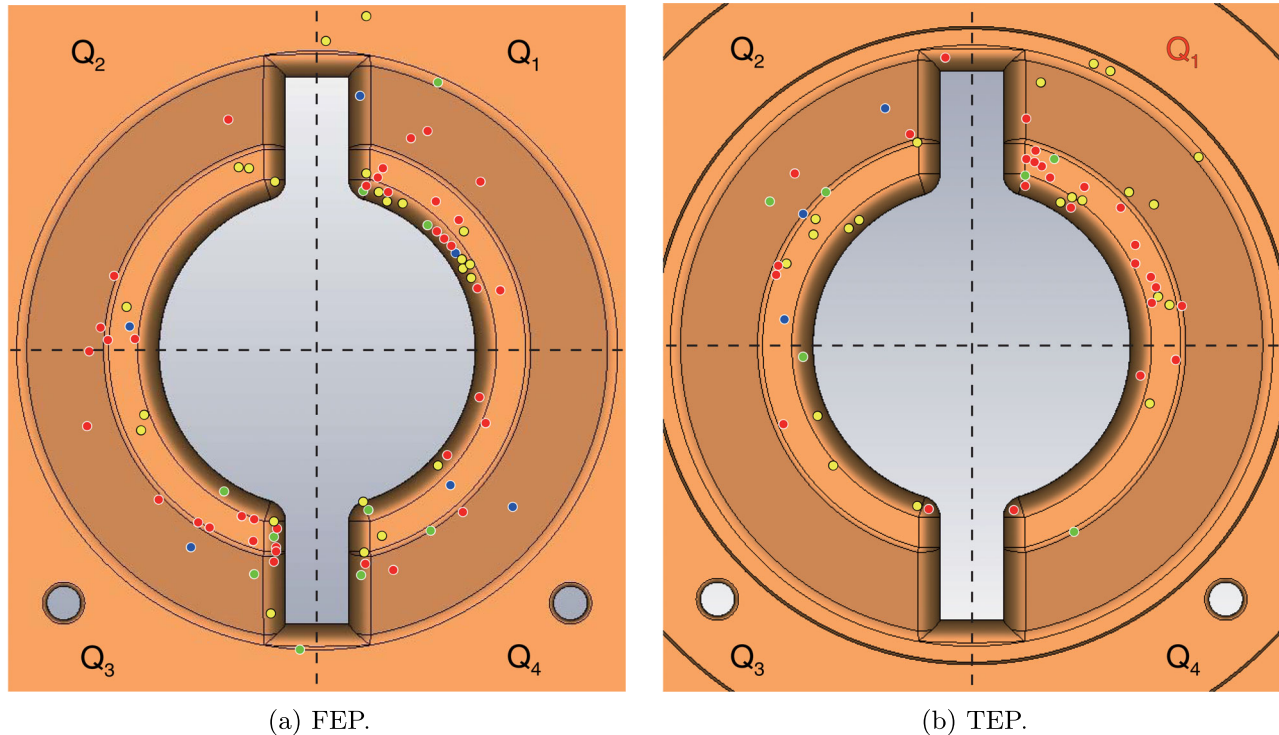
FIG. 17. Distribution of explosion spots for spot-type explosion events, shown as circles. The plot colors of blue, green, yellow, and red indicate cavity voltage ranges of $V_c \leq 0.40$ MV, $0.40 \text{ MV} < V_c \leq 0.60$ MV, $0.60 \text{ MV} < V_c \leq 0.80$ MV, and $0.80 \text{ MV} < V_c \leq 0.95$ MV, respectively, at the moment of cavity breakdown. The small holes, two each for the FEP and TEP, are monitor ports for pickup antennas. The horizontal and vertical dashed lines define the quadrants used in Fig. 18. This partitioning yields the smallest possible sections having the same geometry. Quadrant Q_1 of the TEP, shown in red, is where the brazing filler metal leaked (Appendix B), and the effect of the leakage was at a visual maximum.

Figure 17 shows the locations of the explosion spots on the end plates for the spot-type explosion events (132 points in total, sum of the numbers in the “spot-type explosion of a stable bright spot” and “spot-type explosion

not originating from a stable bright spot” columns in Table IV). Here, the information obtained by TV camera 1 was often used to distinguish on which end plate (the FEP or TEP) the explosion occurred by detecting the brighter side when a cavity breakdown occurred. The fraction of the bright spot explosions that occurred on the FEP was $76/132 = 0.576^{+0.046}_{-0.047}$, where the binomial error is given with a 1σ confidence interval. The statistical significance of the deviation from perfect uniformity (fraction of 0.5) is 1.65σ (within the 90% confidence interval); therefore, the difference between the numbers of events occurring on the FEP and TEP ($76 - 56 = 20$) is not statistically significant. However, nonuniformity can be seen in the azimuthal direction for both the FEP and TEP. Figure 18 quantitatively shows the nonuniformity; the maximum significance for the FEP is 2.66σ at Q_1 (outside the 99.2% confidence interval), which is not clearly significant. In contrast, the maximum significance for the TEP is 4.17σ at Q_1 (outside the 99.996% confidence interval), which is clearly significant. We demonstrated that this significant nonuniformity is correlated with the leakage of the brazing filler metal into the cavity from between the TEP and the barrel (Appendix B). No other causes of this nonuniformity were found in the production process of DR cavity No. 2. Therefore, we

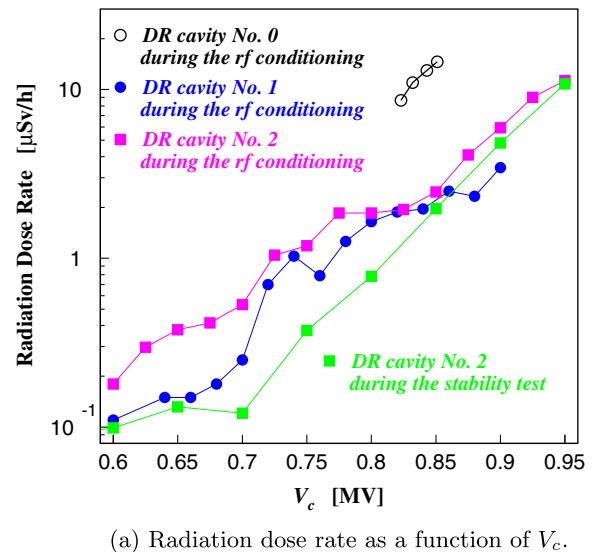
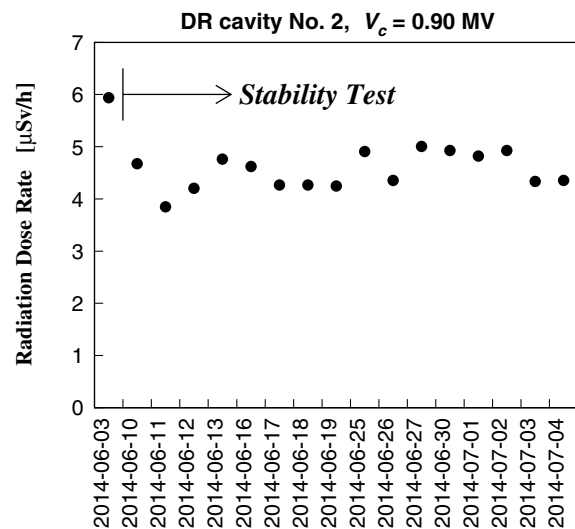
(a) Radiation dose rate as a function of V_c .

(b) Radiation dose rate as a function of time (day).

FIG. 19. Radiation dose rates measured approximately 2 m from the cavities in the radiation-controlled area. The background level was approximately $0.1 \mu\text{Sv/h}$.

conditioning then remained almost constant during the stability test. This is consistent with the data shown in Fig. 19(a), which demonstrates that the field emission level reached a minimum at the end of the rf conditioning. This means that the stable bright spots, which exploded when the cavity breakdown occurred, were not dominant continuous field emitters during the stability test before the explosion.
