Surface investigation on prototype cavities for the European X-ray Free Electron Laser

The accelerating gradient Eacc of X-ray Free Electron Laser (XFEL) prototype cavities manufactured at the industry and treated at DESY demonstrates wide-range scattering from 15 to 41 MV/m. Most cavities satisfy the XFEL specification. Few cavities with low performance (15–17 MV/m) are limited by quench without field emission. The T-map analysis detected quench areas mainly close to the equator. Optical control by a high resolution camera has been applied and allowed to monitor the defects in some cases with good correlation to T-map observation. In order to understand the cause of reduced performance and get more detailed information of the origin of defects, some samples have been extracted from two cavities and investigated by light microscope, digital light microscope with 3D profile measurement, scanning electron microscope SEM, energy dispersive x-ray analysis, and Auger spectroscopy. The electron backscattered diffraction method in a SEM is used to make localized measurements of the lattice curvature. Several surface flaws with sizes from a few μm to hundreds of μm detected by microscopy.

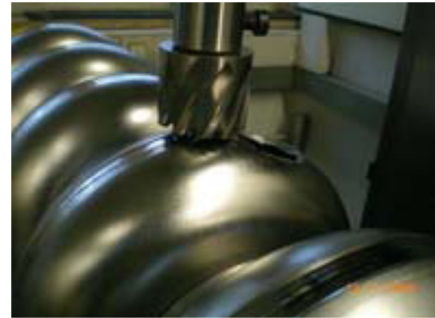
Several samples were taken from cavities Z111 (BCP-flash treated) and Z130 (final EP treated). The separation of the samples from cavity was done using milling machine and special adapter allowing separating samples of disklike shape with a diameter of ca. 35 mm (Fig. 2). The rotation speed of the milling cutter did not exceed 50 rpm. The damage of the sample's surface by metal filings or by the sample falling down inside the cavity was avoided. The cutting was done in a conventional environment without any lubrication. The temperature of the samples during separation did not exceed 50°C . Cavities additionally were previously high pressure water rinsed. The samples were taken from cavity quench areas or areas with increased heating (hot spots) that were localized by T-mapping during vertical rf test.

FIG. 2. Separation of samples for surface investigation

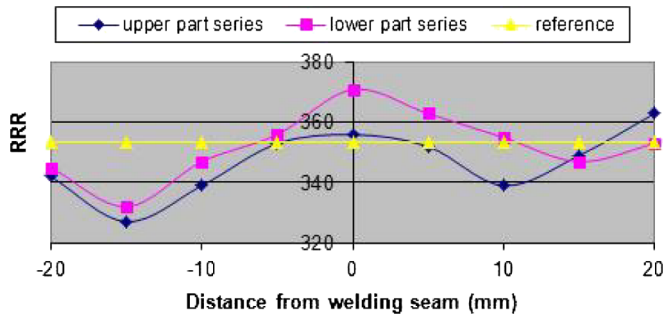
FIG. 15. RRR in welding area (electron beam welding at pressure 2.3×10^{-8} mbar).
