Structure of GaAs(001) (2×4) - $c(2 \times 8)$ Determined by Scanning Tunneling Microscopy

M. D. Pashley, K. W. Haberern, and W. Friday

The scanning tunneling microscope (STM) has been used to study the (2×4) - $c(2 \times 8)$ reconstruction on the arsenic-rich surface of GaAs(001). The STM images show that the $4 \times$ periodicity is due to a regular array of missing arsenic dimers. The (2×4) units are arranged so as to give small domains of either (2×4) or $c(2 \times 8)$ reconstructions. These images are the first high-resolution STM images obtained from a surface grown by molecular-beam epitaxy. Features are seen which may be important in the mechanism of growth.

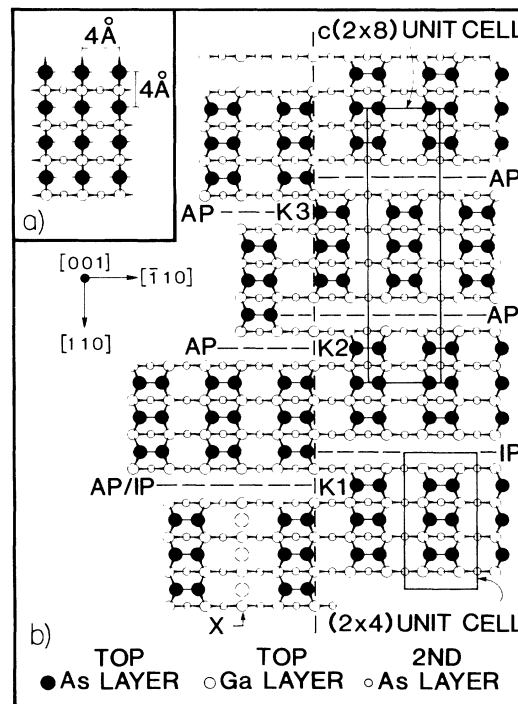
FIG. 1. (a) The structure of the unreconstructed GaAs(001) arsenic-rich surface. (b) The missing-dimer model for the GaAs(001) (2×4) surface. The two types of missing-dimer boundary, in-phase (IP) and antiphase (AP), are shown giving rise to (2×4) and $c(2 \times 8)$ structures. The intersection of a domain boundary along the $[110]$ direction with the IP and AP boundaries is shown giving rise to three types of boundary kinks: K_1 , K_2 , and K_3 . Disorder in the arsenic pairing (X) with three missing arsenic atoms (dashed circles) is also shown.

\AA^2 bright features. Since filled states are localized on the arsenic atoms,¹³ the bright regions of the image should correspond to the positions of arsenic atoms. The STM images are consistent with each unit cell containing three dimers and a missing dimer as shown in Fig. 1(b). The dark bands correspond to the rows of missing dimers and the bright features correspond to the three dimers within a (2×4) unit cell. The six arsenic atoms forming the three dimers in a unit cell, together with the sites of the two atoms of the missing dimer, have been drawn in for one unit cell in Fig. 2. This image also shows several types of defects which are discussed below. Thus, although the unit cells are clearly resolved, we are generally not able to resolve the individual dimers. Figure 3 shows an image which does have slightly better resolution (probably because of a favorable tip condition). In this case there is some detail within the bright regions of the unit cell. This is most easily seen around the kink marked K_3 in Fig. 3. It is clear that the bright region corresponding to the dimers is divided into at least two. This division splits the bright feature into $\frac{1}{3}$ and $\frac{2}{3}$ (not halves). Careful examination of some of the unit cells (particularly around K_3) shows the $\frac{2}{3}$ section is itself divided in half, resulting in the bright feature being divided into thirds, corresponding to the three dimers. The unit cells on either side of the kink are displaced by 4\AA

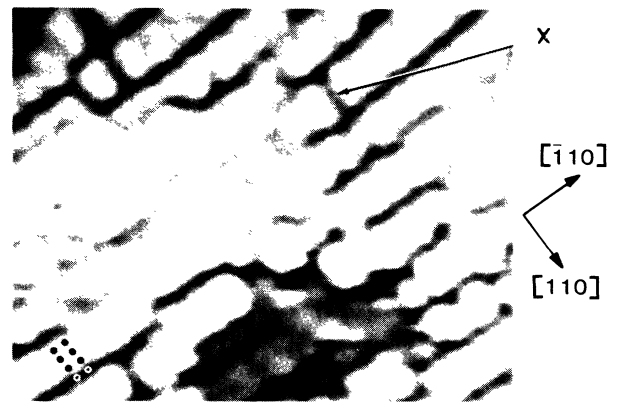
FIG. 2. A typical STM image of the GaAs(001) (2×4) surface showing a $165\times 130\text{-}\text{\AA}^2$ area including small islands one plane up (light) and one plane down (dark), each having the same structure as the main plane. Disorder in the pairing of arsenic atoms can be seen at X. The upper right-hand side of the image is a region of well-ordered (2×4) . The atom positions are marked with filled circles and the missing-atom sites are marked with open circles. The image was taken with the sample at -2.3-V and 0.2-nA tunneling currents. The gray scale covers a vertical height of 7 \AA .

The STM image shown in Fig. 2 is typical of the images obtained from this surface. The image is displayed as a gray scale with black low and white high. The most obvious features are dark bands running along the $[\bar{1}10]$ direction with a spacing in the $[110]$ direction of 16 \AA [calibration being made from previous observations of the Si(111) (7×7) surface¹¹] corresponding to the $4\times$ spacing. The width of these dark bands is 4 \AA with the bright regions in between being 12 \AA wide. The bright areas also have a periodicity along the $[\bar{1}10]$ direction of 8 \AA corresponding to the $2\times$ spacing. The resolution of this image is not sufficient to see detail within the $8\times 12\text{-}\text{\AA}$

the lower energy of the two.⁹ The upper right of Fig. 2 shows a region of well-ordered (2×4). Our STM images clearly show that both types of boundaries are present on the surface, with domains being as small as a few unit cells across.

In addition to the determination of the structure of the unit cell, the STM is able to directly image disorder and defects on the surface. We have already discussed the boundaries leading to the (2×4) and $c(2\times 8)$ unit cells. There are other possible disorder structures which might also exist on the surface. An in-phase boundary can become an antiphase boundary by a local disorder in the pairing up of arsenic atoms to form dimers [Fig. 1(b)]. This leaves three unpaired As atoms between two unit cells. We have seen several examples of this type of disorder where the three unpaired As atoms are actually missing (Fig. 2). It is possible to have domain boundaries along the [110] direction [Fig. 1(b)]. These produce kinks in the missing-dimer rows. As shown in Fig. 1(b), the intersection between these boundaries and an in-phase boundary forms only one type of kink structure (K_1). However, there are two types of kink structure which can be formed with the antiphase boundary; an open kink (K_2) and a closed kink (K_3) [Fig. 1(b)]. None of our STM images show extended domain boundaries along the [110] direction. A few kinks in the missing-dimer rows are seen, but these do not involve extended [110] domain boundaries. They are associated either with steps or regions of disorder (Figs. 2 and 3). Examples of a K_3 -type kink are clearly seen in both Figs. 2 and 3, both on small ordered regions of only a few unit cells in size. No examples of a K_2 -type kink have yet been seen. Other local defects seen on the surface include unit cells with two or more missing dimers, as well as a few unit cells with no missing dimers (Fig. 2).

In terms of growth mechanisms, the types of defects that are more important are steps and island structures. The STM images show that the surface is generally flat. When steps are observed, they are 2.8 Å high, corresponding to the spacing between arsenic planes and not between arsenic and gallium planes (Fig. 2). Thus the arsenic-rich surface is preserved at steps. No larger height steps have been seen. One of the more interesting features seen from the point of view of growth mechanisms is the small "islands" of only a few unit cells in size, and they are either one 2.8-Å step up or step down

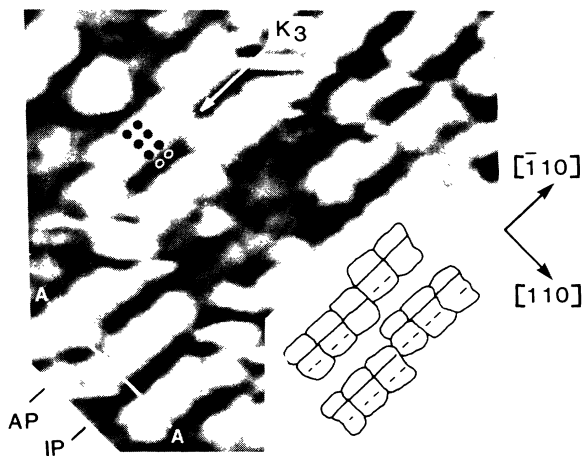
FIG. 3. STM image of the GaAs(001) (2×4) surface. Some of the individual arsenic dimers are just resolved. The unit cell is $8 \times 16 \text{\AA}^2$. The atom positions are marked with filled circles and the missing-atom sites are marked with open circles. The two possible types (IP and AP) of missing-dimer boundary are seen leading to areas which are (2×4) -like and areas which are $c(2 \times 8)$ -like. The line $A-A$ shows the unit cells to be in phase across the IP boundary and out of phase across the AP boundary. A K_3 kink is marked on the image. Inset: Drawing of the unit cells around the kink. Solid lines represent well-resolved features and dashed lines represent features at the limit of resolution for this image. The image was taken with the sample at -2.4-V and 0.2-nA tunneling currents. The gray scale covers a vertical height of 3.5\AA .

(i.e., one dimer) along the $[110]$ direction. The width of the dark rows (corresponding to missing dimers) is the same as the width of one dimer (4\AA). Since the features described in Fig. 3 are not easily seen, we have included a drawing of the region around the kink, as an inset to the figure. The solid lines represent distinct features, while the dotted lines are features seen at the limit of the resolution of this image. The difference in appearance of the two boundaries between dimers within a unit cell probably relates to the tip condition rather than an asymmetry within the unit cell. The tip was scanning the surface from left to right in the image. The first boundary within the block of dimers that was encountered after the tip moved from the missing-dimer row to the dimers is clearly seen, whereas the second is either missing or only just visible. This could be explained by a slightly asymmetric tip. Effects resulting from asymmetric tips have been observed by others.¹⁴ The unit cell structure would be expected to be symmetrical. However, we cannot completely rule out an electronic effect leading to such an asymmetry. There are a few unit cells in Fig. 3 which appear to have two dimers and two missing dimers per unit cell. Our many images of this surface show that this type of unit cell occurs only occasionally. The additional missing dimer can thus be thought of as a local defect in the equilibrium (2×4) structure. Calculations have shown that a unit cell with two missing dimers is 0.2 eV per (1×1) unit higher in energy than a (2×4) unit cell with only one missing dimer.⁹ We conclude that our STM images show the $4 \times$ periodicity on this surface to arise from missing dimers, and that the data are best explained by Chadi's model of three dimers and one missing dimer per unit cell.⁹ The $4 \times$ periodicity does not arise from tilting of the dimers as suggested in earlier models.^{7,8} Although we see no evidence of tilting of the dimers, our images are not of sufficient resolution to determine if they are precisely planar.

If we consider the rows of missing dimers as boundaries between units of three dimers, then it can be seen from Fig. 3 that there are two different types of boundary present on the surface. An in-phase boundary (marked IP in Fig. 3) occurs when the units of three dimers line up on either side of the boundary. By comparison with Fig. 1(b), it can be seen that this corresponds to the (2×4) reconstruction. An antiphase boundary (AP) occurs when the center of a block of three dimers on one side of the boundary lines up with the interface between two dimer units on the other side of the boundary. This leads to a larger unit cell [Fig. 1(b)] which is $c(2 \times 8)$. Thus the $c(2 \times 8)$ structure is actually built up from subunits of (2×4) , the two structures only differing by the type of boundary (in-phase or antiphase) formed by the missing-dimer rows. Calculations on the difference in energy between these two show it to be only 0.12 eV per $c(2 \times 8)$ unit cell, the $c(2 \times 8)$ structure having

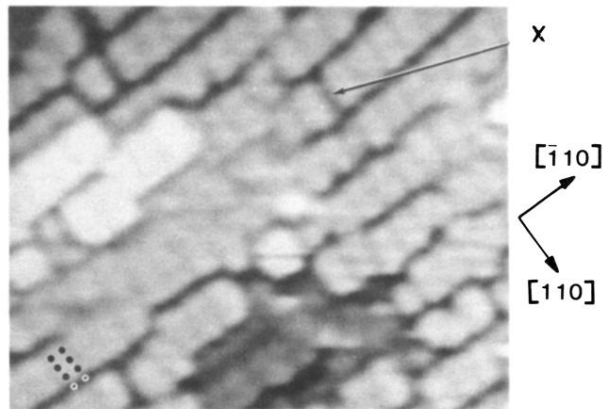
FIG. 2. A typical STM image of the GaAs(001) (2×4) surface showing a $165 \times 130 \text{-}\text{\AA}^2$ area including small islands one plane up (light) and one plane down (dark), each having the same structure as the main plane. Disorder in the pairing of arsenic atoms can be seen at X . The upper right-hand side of the image is a region of well-ordered (2×4). The atom positions are marked with filled circles and the missing-atom sites are marked with open circles. The image was taken with the sample at -2.3-V and 0.2-nA tunneling currents. The gray scale covers a vertical height of 7\AA .

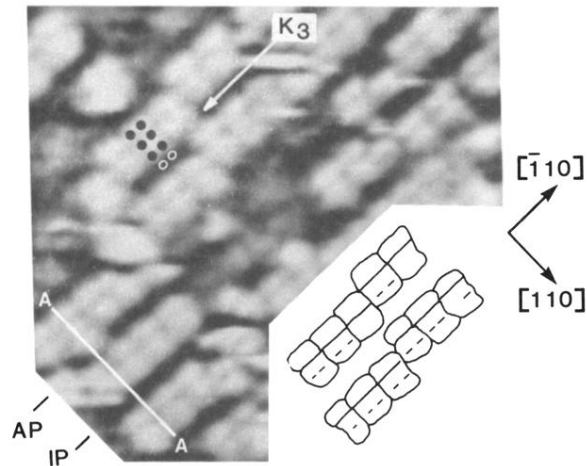
FIG. 3. STM image of the GaAs(001) (2×4) surface. Some of the individual arsenic dimers are just resolved. The unit cell is $8 \times 16 \text{ \AA}^2$. The atom positions are marked with filled circles and the missing-atom sites are marked with open circles. The two possible types (IP and AP) of missing-dimer boundary are seen leading to areas which are (2×4) -like and areas which are $c(2 \times 8)$ -like. The line $A-A$ shows the unit cells to be in phase across the IP boundary and out of phase across the AP boundary. A K_3 kink is marked on the image. Inset: Drawing of the unit cells around the kink. Solid lines represent well-resolved features and dashed lines represent features at the limit of resolution for this image. The image was taken with the sample at -2.4-V and 0.2-nA tunneling currents. The gray scale covers a vertical height of 3.5 \AA .
